Preliminary Information

PIT5834B A/C Blows Warm Intermittently Or Takes A Long Time To Start Cooling

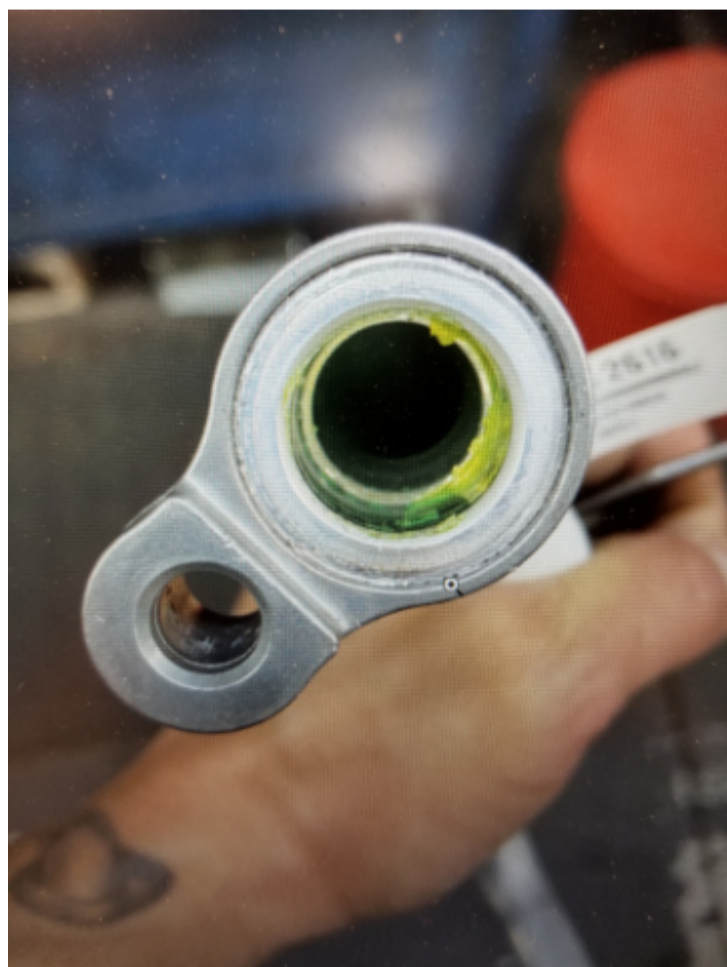
Involved Region or Country:	North America
Condition:	A/C is slow to cool, takes longer to blow cool air when compared to like vehicle or if the vehicles refrigerant needs to be evacuated for another repair.
Cause:	Possible A/C refrigerant contamination.

If you duplicate this condition and the vehicle was built during the above time period, recover the refrigerant using the GE-50957 Contaminated Refrigerant Recovery Machine. Remove the line from the condenser and the TXV and look for contamination like illustrated in the pictures below. If you have this contamination, take pictures of the fittings, open a TAC case and attach them to the case. Your case will be reviewed and you will be contacted directly. If you do not see visible contamination like below reinstall the lines and diagnose using the performance chart and diagnostics in Service Information.
