Date: May 13, 2021

**Subject: D200 Axle Series (20K-27K) Oil Cap Torque**

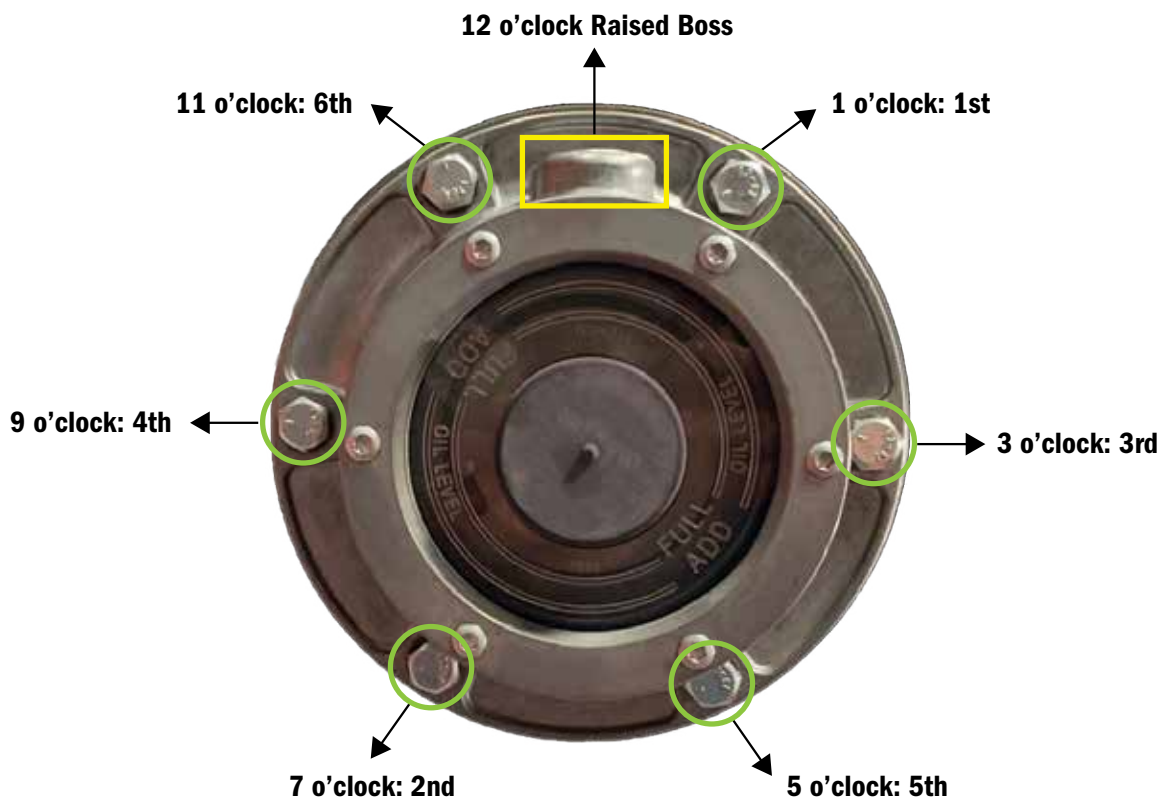
For D200 series axles (20K-27K) built at plant 12 in Fremont, IN, there is a possibility that oil caps may not have been properly torqued from a period between March 1, 2020 to May 10, 2021. If the oil cap mounting bolts are not properly torqued, this may result in an oil leak. Recommendation is to confirm proper torque per the following instructions noted below.

**Note:** The oil cap shown is representative only. The service bulletin applies to all oil caps supplied on D200 series axles. Please contact Dexter customer service for additional information or if you need further assistance.

1. When reviewing your D200 series oil cap, locate the raised boss that contains the threaded oil fill insert. For the general purpose of a tightening pattern, this location will be considered 12 o'clock no matter the orientation to the ground.
2. Tighten each individual bolt to a value between 10–15 Ft. Lbs. following the pattern shown below.
3. If needed, remove the rubber end plug and add the recommended oil type until the level reaches the "FULL" marking on the clear face of the oil cap. Be sure to return rubber plug back to the oil cap and that the rubber plug is fully seated into position and no gaps between plug and lens face are present.
