48 Electric steering column adjustment is not working, DTC B14BF01 is stored in the BCM 1

48 21 01 2062288/3 May 14, 2021. Supersedes Technical Service Bulletin Group 48 number 21-95 dated March 8, 2021 for reasons listed below.

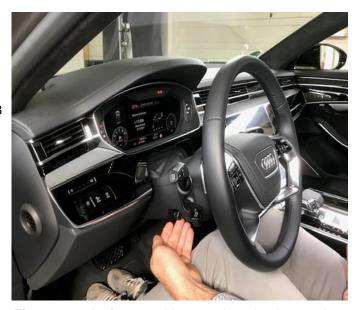
Figure 1. 40 kg force pushing steering wheel upward.

- 3. The function of the electric steering column adjustment must be restored. Proceed as follows:
 - Get into the vehicle and use your knees to push the steering wheel upward (a force of approx. 40 kg or 88 lbs is required), at the same time press the steering column adjustment switch upwards in the vertical adjustment direction (Figure 1).
 - This will restore the function of the electric steering column adjustment.

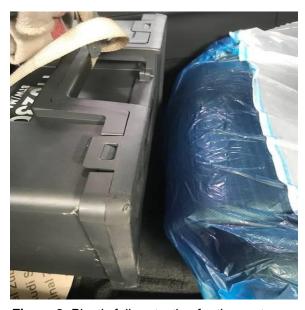
Figure 3. Plastic foil protection for the seat.

7. Apply plastic foil to make sure the tool kit cannot scrape against the seat (Figure 3).
