51 Cracking noises in right rear roof area during steering thrust

51 21 22 2060145/4 May 11, 2021. Supersedes Technical Service Bulletin Group 51 number 20-19 dated December 18, 2020 for reasons listed below.

Model(s)	Year	VIN Range	Vehicle-Specific Equipment	
Q8, SQ8	2019 - 2021	All	Not Applicable	
RS Q8	2020 - 2021	All	Not Applicable

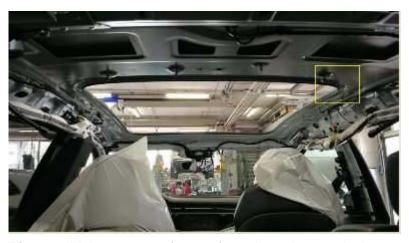
Remove the headliner and sliding sunroof assembly. Figure 1 shows the area to be reworked in the rear of the sunroof opening, beginning with the right rear.

Figure 1. Right rear area of sunroof opening to be reworked.

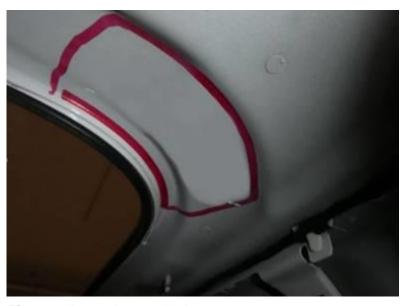
2. Figure 2 shows a close-up view of the area to be reworked.

Figure 2. Area to be reworked.

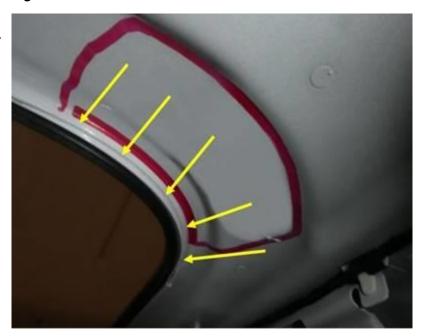
Figure 3. The yellow arrows show the joining seam of the outer roof sheet metal to be separated from the inner roof support.

The outer roof sheet metal is to be separated from the inner roof support (Figure 3).

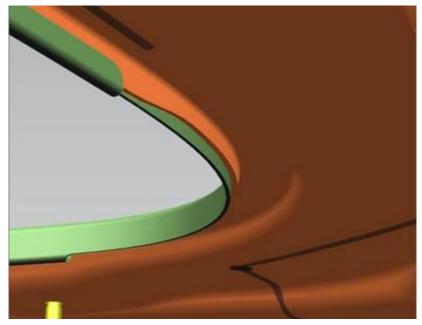
4. The drawing in Figure 4 shows the adjoining sheet metal that will be separated.

Figure 4. The section colored green is to be separated from the section colored orange in this drawing.

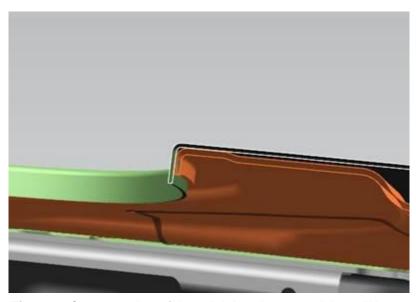
5. Figure 5 shows a cut-away view of the adjoining sheet metal that will be separated.

Figure 5. Cut-away view of the adjoining sheet metal that will be separated.

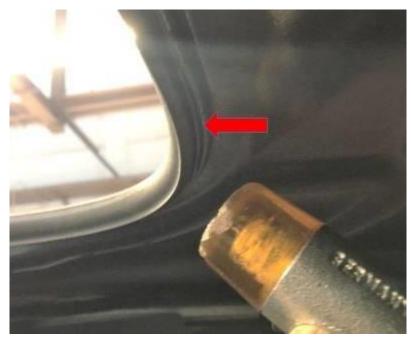
Figure 6. Area of sheet metal to strike with a plastic mallet.

Figure 6 shows the area of the roof sheet metal to strike with a plastic mallet. A light strike should suffice.

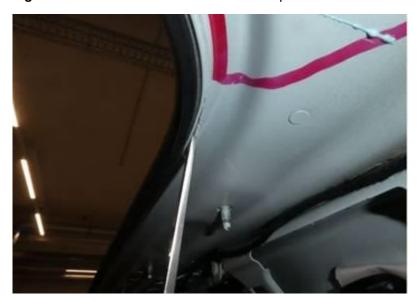
Figure 7. Adhesive joint separated.

If separation of the sheet metal proves to be more difficult than a light strike of a plastic mallet will produce use a small screw driver or small chisel to break away the adhesive (Figure 7).

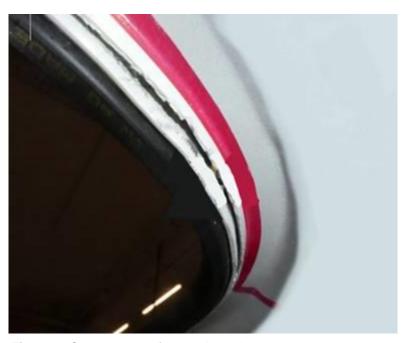
Figure 8. Create a gap of approximately 1mm.

Separate the adjoining sheet metal approximately 1mm (Figure 8).

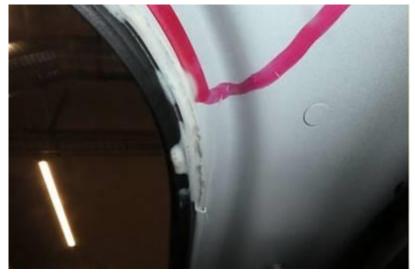
Figure 9. Gap created filled with Cavity Wax.

Through this gap fill the cavity with 08852 Cavity Wax Plus (Figure 9).
