66 Door cover trim is loose

66 21 72 2063197/1 May 11, 2021.

Model(s)	Year	VIN Range	Vehicle-Specific Equipment
Audi e-tron quattro	2019 - 2021	All	Not Applicable
Audi e-tron Sportback	2020 - 2021	All	Not Applicable

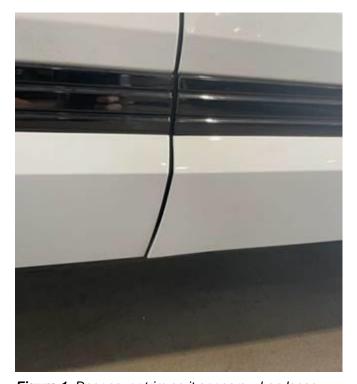
• The front door lower cover trim appears loose as if pulled away from the door.

• The trim is not flush with the cover trim on the rear door (Figure 1).

Figure 1. Door cover trim as it appears when loose.

The two main pieces that comprise the door cover trim become disengaged one from the other if the trim is exposed to a sudden force such as contact with a foot during exit and entry or forceful closing of the front door. This symptom is only known to occur on the front door cover trim.

The door cover trim does not need to be removed from the vehicle to perform this repair. The two main pieces that comprise the lower door cover trim must be reconnected. Before reconnecting the pieces 2K plastic adhesive D 180 KU2 A1 (or alternatively D 180 KU1 A1) will be applied to prevent further instances of disengagement.

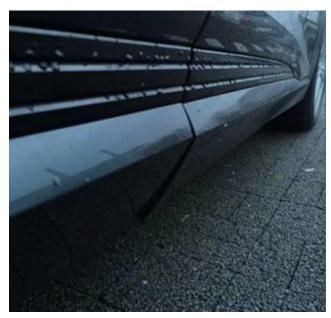
Figure 2. Disengaged door cover trim.

While the customer's vehicle may present with this symptom on one of the front doors and not both, apply the following bonding procedure to both front door lower cover trims (Figure 2). If the component parts of the trim are not yet disengaged they can be disengaged for the purposes of repair by pressing the inner trim upward and away from the outer shell.

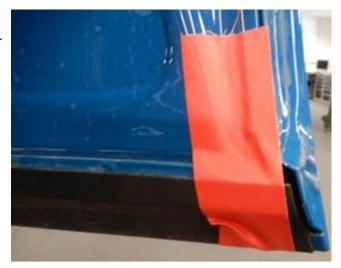
Figure 7. Painter's tape binding the newly adhered trim pieces.

7. Immediately press the inner trim slightly upwards then toward the outer shell and back down again. The two pieces are now reengaged correctly. Remove any excess adhesive immediately. Place a strip of painter's tape as shown in Figure 7 to keep the two pieces together during the adhesive curing time.
