Technical Service Bulletin

91 MIB2+: lower display flickering after a software update

91 21 01 2061029/4 May 14, 2021. Supersedes Technical Service Bulletin Group 91 number 20-47 dated December 17, 2020 for reasons listed below.

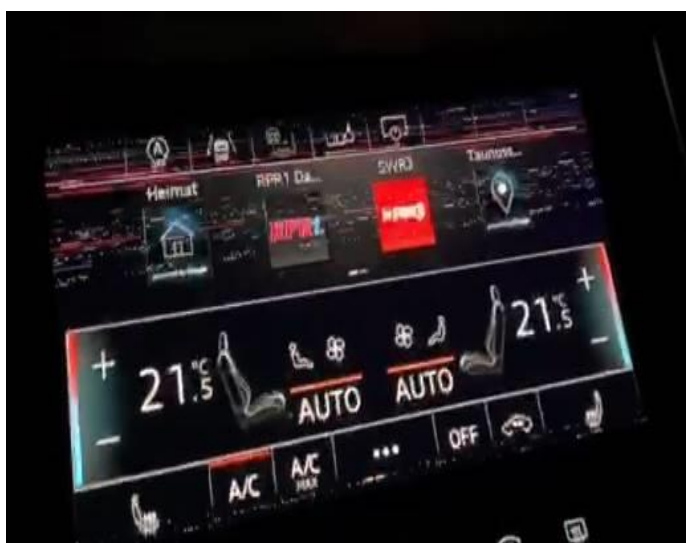
- After a MMI Software update has been completed, the lower display sporadically flickers (Figure 1).

Figure 1. The display sporadically flickers.

There are compatibility issues between the display and the MMI software.

Update the MIB2+ display using either Method 1 or Method 2 according to TSB 2056558: *91 MIB2+ Software Update Instructions* and use SVM code 636S002.
