# Technical Service Bulletin

## 00 Bolts for the charging station are missing

00 21 45 2063335/1 May 17, 2021.

Model(s)	Year	VIN Range	Vehicle-Specific Equipment
Audi e-tron quattro, Audi e-tron Sportback	2021	All	e-tron

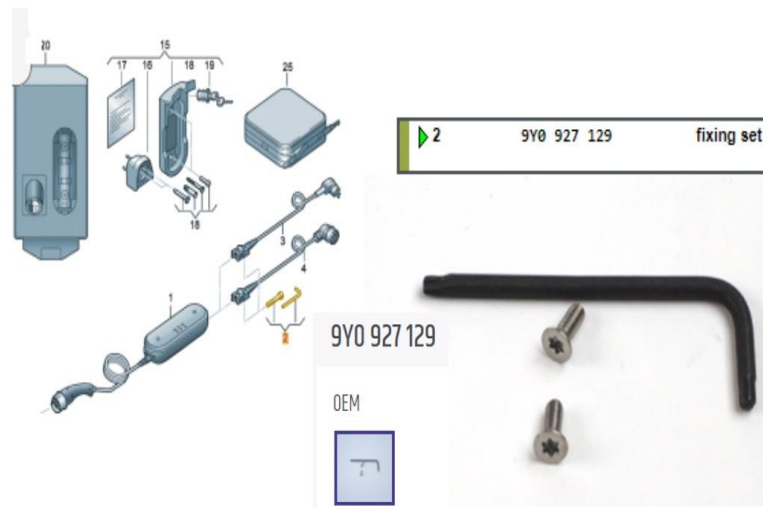
Bolts (part number 9Y0 927 129) for securing the connector in the charging unit have been discontinued (Figures 1 - 2).

Figure 1. Bolts.

As of production date 01/11/2021, the fixing bolts can be ordered via the parts system if the customer desired them but cannot be invoiced under warranty.

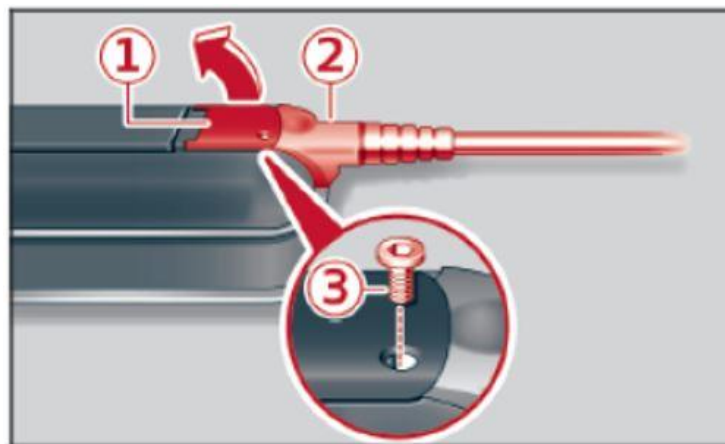
*Figure 2. The location where the bolts used to be installed.*
