Technical Service Bulletin

26 Noises are heard from the exhaust at idle, DTCs P047600, P048C00, P04A000, or P301B00 are stored in the ECM

26 21 45 2058998/3 May 18, 2021. Supersedes Technical Service Bulletin Group 26 number 21-44 dated February 1, 2021 for reasons listed below.

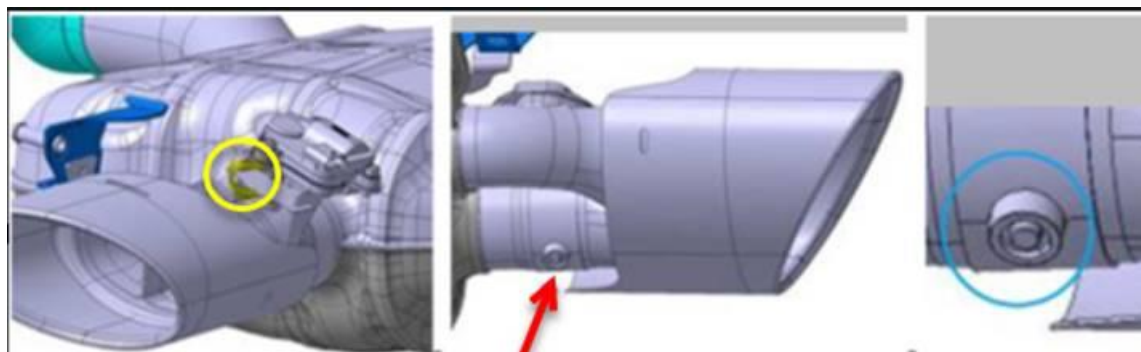
Figure 2. Old rear silencer.

- A. Old version (Figure 2): C-bracket (marked yellow) and moveable bearing (blue). **It is not compatible with an optimized control motor.** The complete rear silencer has to be replaced.

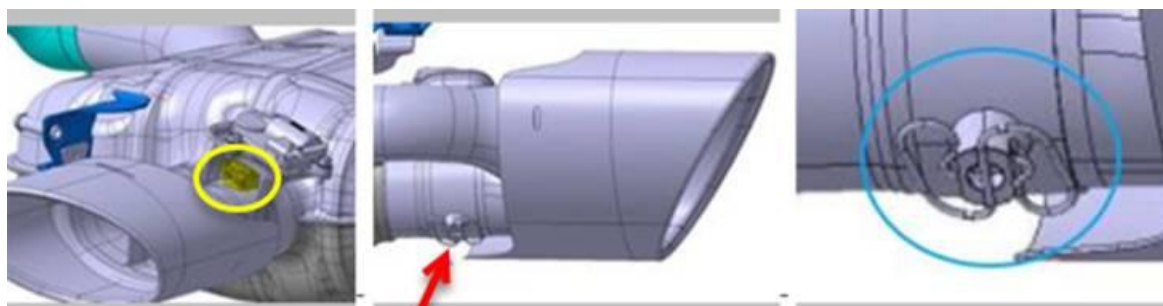
Figure 3. The optimized version of the rear silencer.

- B. Optimized version (Figure 3): claw coupling (marked yellow) with spring lock (blue). Check which version of the control motor is fitted: If the control motor fitted is not the new version (part number 8S0 133 246 D), replace it individually on the exhaust flap with the concern.
