4/30/21

SERVICE ADVISORY # 21-406

Cougar, Carbon, Fuzion, Impact, Raptor Skylights

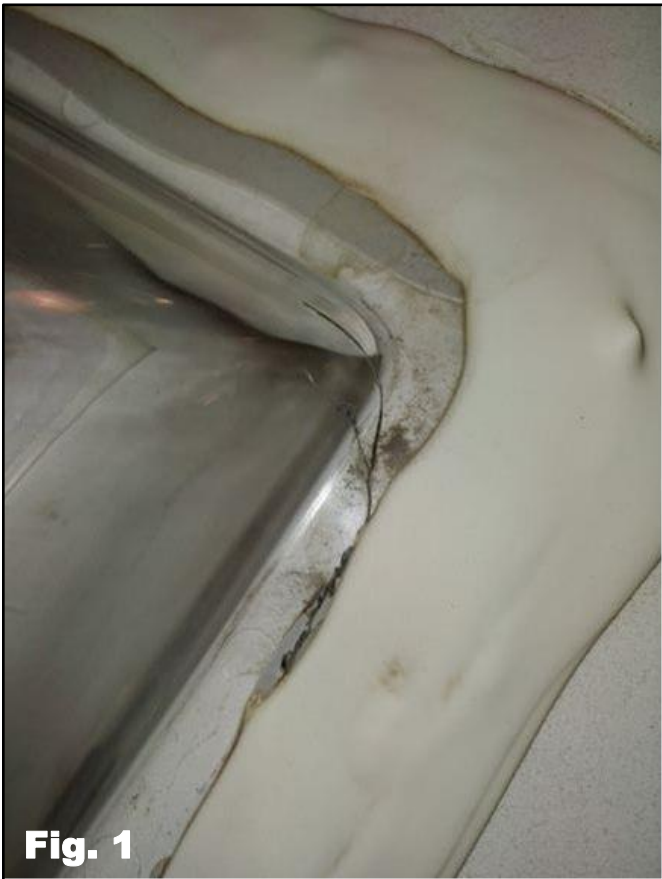
The remedy is to inspect the clear polycarbonate skylight on the Alpha Flex or Alpha Ply roof systems. Inspect the clear skylight for cracks and replace if cracks are found. See Figure 1 as an example. A clear picture is required for authorization and the claim.

Locate the skylight on the exterior roof and inspect for cracks. See Fig 1. If the skylight is cracked, take clear pictures for the authorization showing the defect. If no cracks are present, proceed to warranty reimbursement below and submit a claim for inspection. If the skylight is cracked, proceed to Step 3.

If the skylight is cracked, remove the clear polycarbonate skylight using normal industry standards and replace with the new polypropylene skylight (KRV # 634185) using butyl tape under the skylight as a primary seal and Alphathane (KRV # 639155) as a self-leveling secondary seal, then proceed to warranty reimbursement.
