## STAR ONLINE PUBLICATION

**Case Number:** S2123000020

**Symptom/Vehicle Issue:** A Buzz, Squeak, Rattle (BSR), Clicking Noise Heard From Left Side Of The Freedom Top.

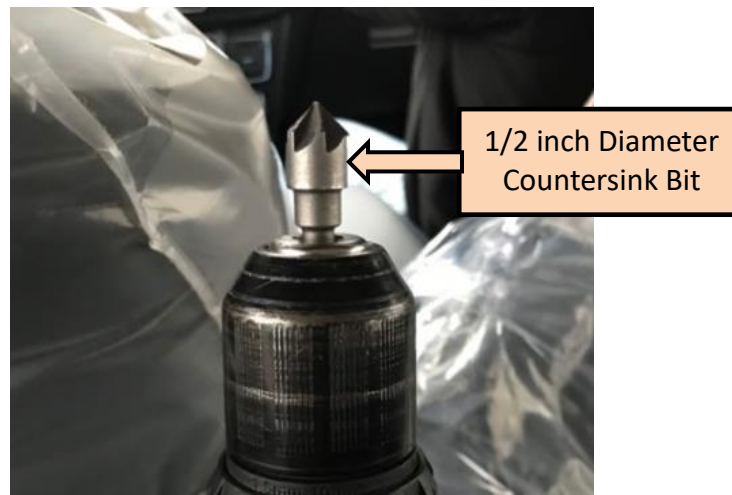
Fig 3: 1/2 inch Diameter Counter Sink bit

3. Use a 1/2 inch Diameter Countersink bit on top of receiver bracket as shown and remove the sharp corner and burr from the upper hole diameter. Figures 3 and 4.
