STAR ONLINE PUBLICATION

Case Number: S2008000113 REV. A

Symptom/Vehicle Issue: No Start Intermittently, Vehicle Requires Multiple Keyless Push To Start Attempts To Start Vehicle, Intermittent Key Not Detected Message

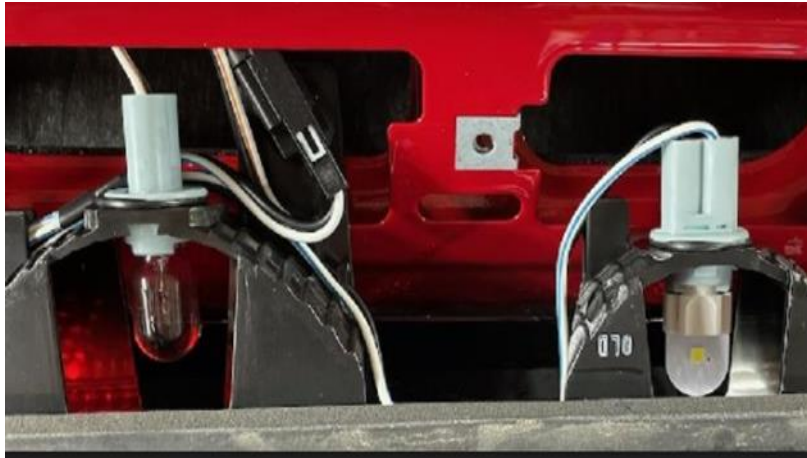
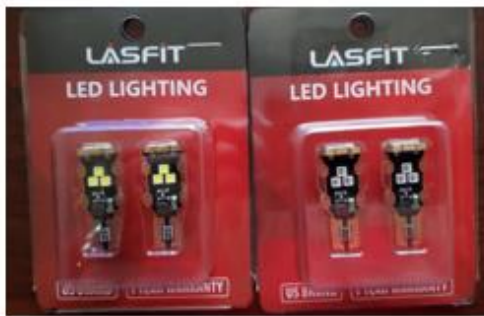
Tech noticed cargo light illumination different than other DTs (dark older shop, easy to recognize).

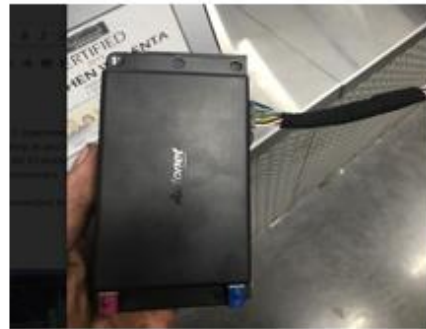
LED replacement bulbs

Autonet Mobile (wireless) installed into the CAN C BUS
