STAR ONLINE PUBLICATION

Case Number: S2023000020 Rev A

Symptom/Vehicle Issue: Tick Noise From A-pillar Front Power Top Side Rail

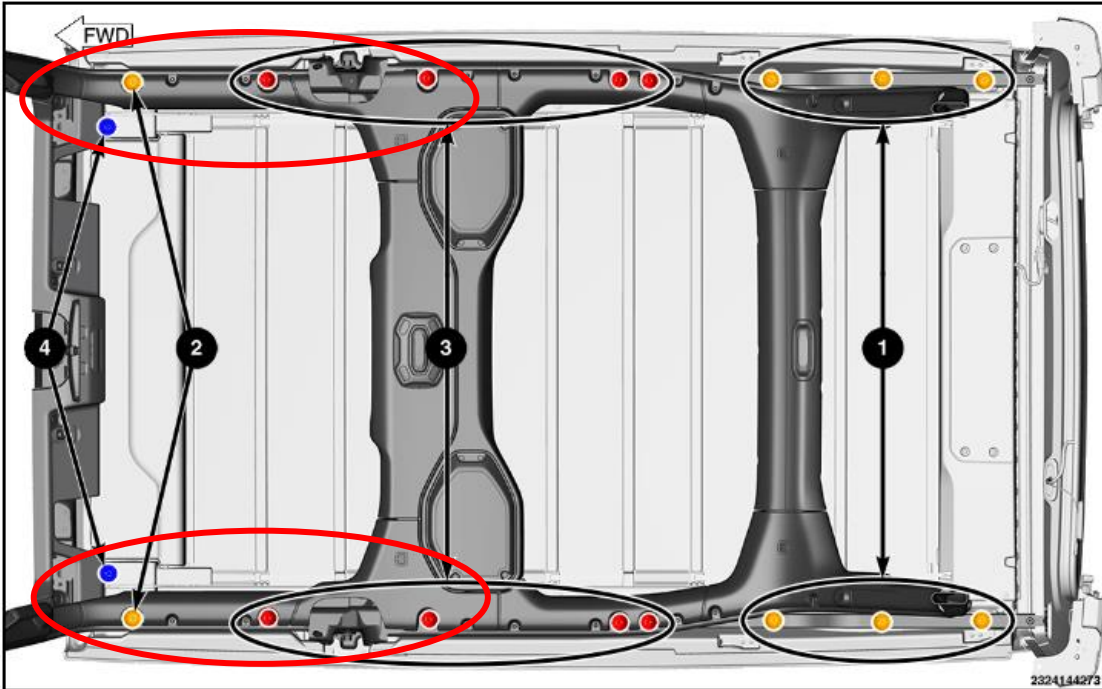
NOTE: The screws that anchor the power top assembly to the frame of the vehicle are different lengths. Damage can occur if a long screw is placed in a short hole. Refer to the illustration for proper screw locations.

1. Power the roof full open.
2. Remove the front four bolts on each side of the assembly (to loosen front of rail to body to gain access to Torx head fasteners between side rail and track)
 - a) Remove the front "blue" screws (#4 below) that secure the front of the power top assembly.
 - b) Remove the front "gold" screws (#2 below) at the front door openings.
 - c) Remove front two "red" screws in oval (#3 below)

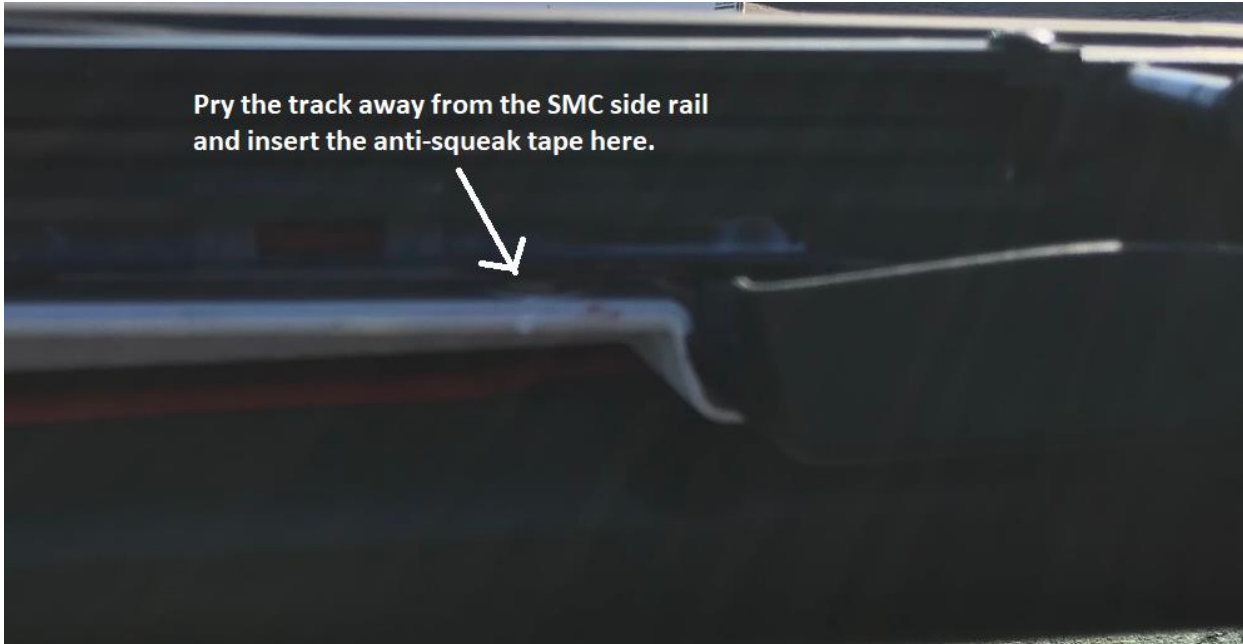
A complaint of a tick or click noise heard from the Sky One power roof system above the front row seat occupant's heads. If the vehicle was built prior to 3/17/21, see the below procedure to add anti-squeak tape.

5. Pry the black aluminum track up and position one piece of tape at the front and at the back of the of the T-nut hole, as shown in the photos below. Tip: apply tape to a blade and carefully slide into opening.

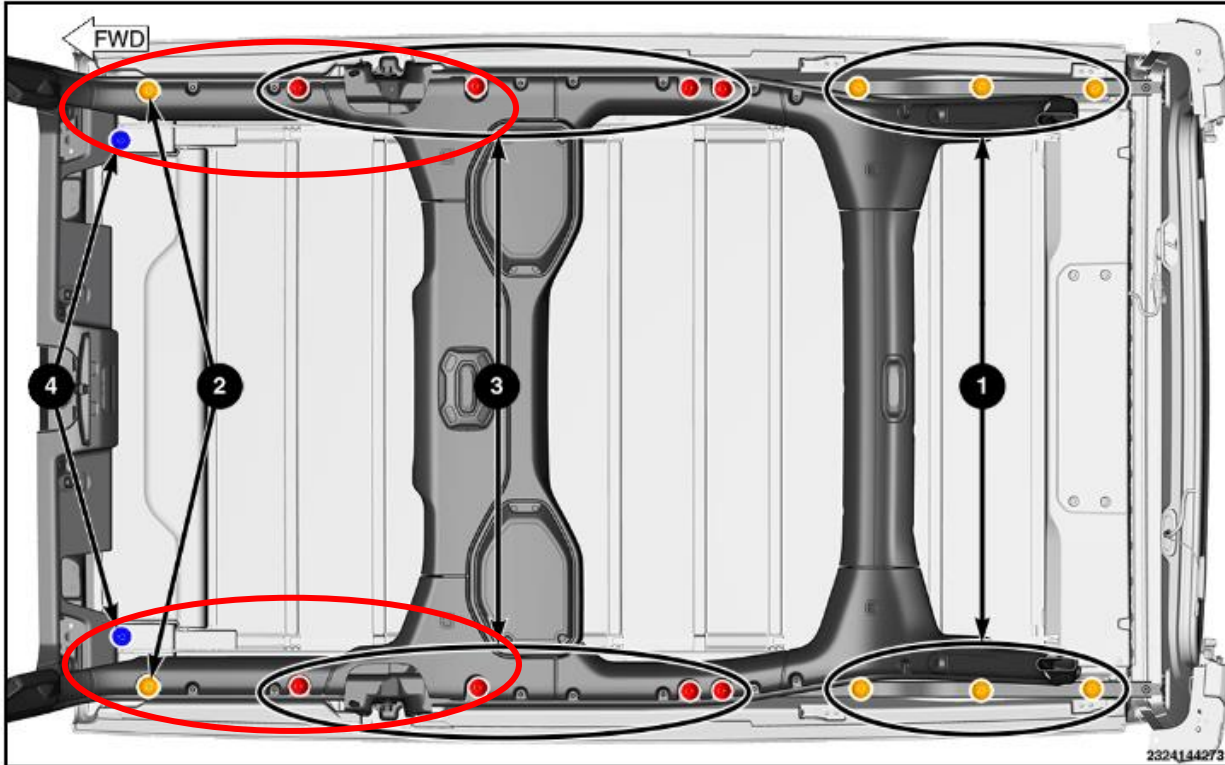
NOTE: The screws that anchor the power top assembly to the frame of the vehicle are different lengths. Damage can occur if a long screw is placed in a short hole. Refer to the illustration for proper screw locations.

7. Attach the front four bolts on each side of the assembly, torque all to 6 Nm.
 - a. Attach the front screw (#2 below) in the front door openings.
 - b. Attach the rear screw in the front door opening and the front screw in the rear door opening, two screws (#3 below).
 - c. Attach the screws (#4 below) that secure the front of the power top assembly.
