STAR ONLINE PUBLICATION

Case Number: S1708000118 REV. A

Symptom/Vehicle Issue: Battery Drain Concern, Dual USB Port Normal Operational Draw, Extended Illumination After Key Off

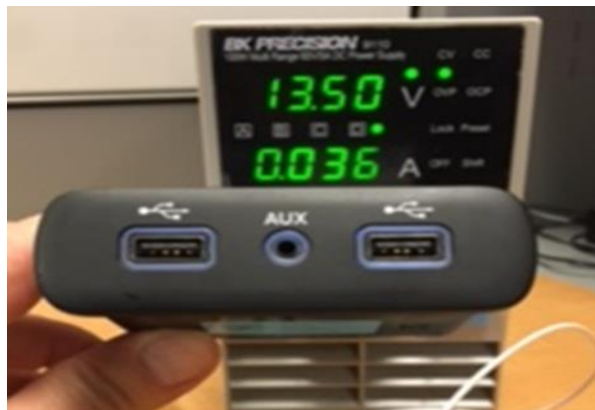
Example of USB port draw

Vehicles equipped with the sales code RS4 - DUAL REMOTE USB PORT – CHARGE come equipped with the active charging feature starting in 2017. The Media hub will continue to charge the users device for up 60min post the ignition and or radio that has been switched off. The draw is expected at approximately 36mA.

NOTE: Do not replace the media port for the battery drainage complaints.
