## UPDATE FROM WARRANTY OPERATIONS

## 2019/ 2020/ 2021 Wrangler/Gladiator (JL/JT) – Hood Switch

## 2020/2021 RAM 1500 (DT) - Transmission Cooling Leaks

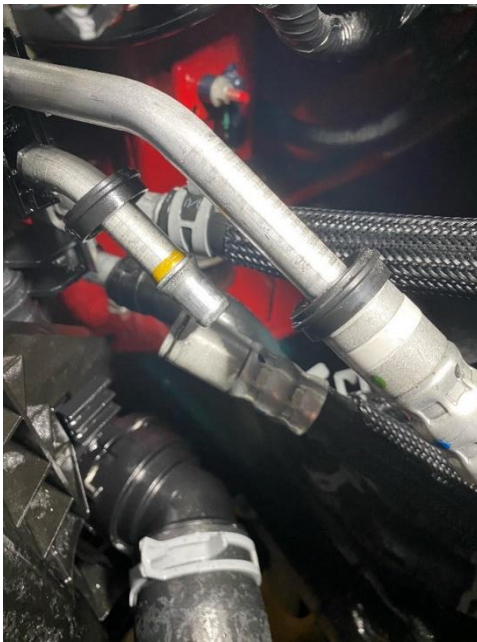
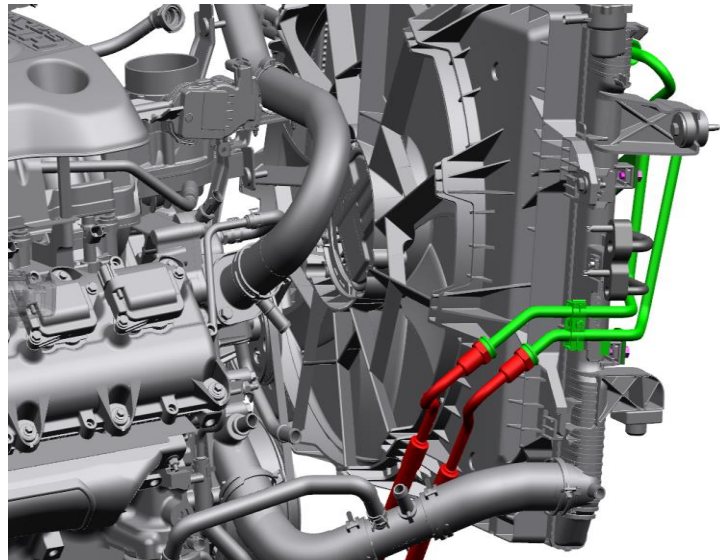
We have seen a recent increase in transmission fluid leaks on 2020 and 2021 RAM 1500 (DT) vehicles with low mileage. We have determined the cause can be related to a loose, not fully inserted, or disconnected quick connector at the joint of the transmission lines to the lines of the Transmission Oil Cooler (TOC).

please inspect the TOC line connections near the cooling module and ensure they are fully connected. If found to be loose or not connected, reconnect the lines and ensure they are secure by completing a push-pull-push. Refill or top-off the transmission fluid, as needed. If no issue is found, proceed with regular diagnostic procedures.

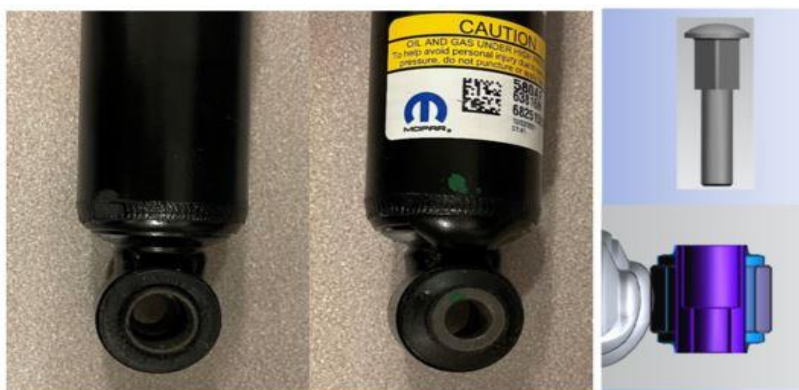
## 2018 - 2021 Jeep Wrangler (JL), 2020 -2021 Jeep Gladiator (JT) Steering Damper

The new JL/JT steering damper (68251580AF) has a counter bore in the lower bushing at the damper to tie rod connection. With the new square shoulder fastener (06513445AA), the assembly must only be assembled with the larger diameter at the 12 o'clock position in the vehicle. This change is to further error proof the assembly orientation of the side intake on the

steering damper. The new target torque spec for this joint is 52 Lb. Ft.

NOTE: New fasteners must be used on every new damper installation. Failure to use the new fastener could cause the damper to be installed in the incorrect orientation.

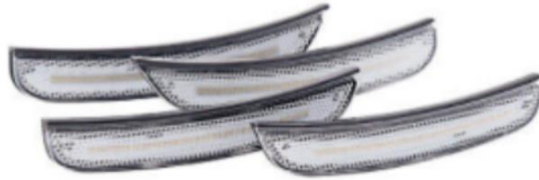
Example: Diode Dynamics LED Side markers

Some After Market Devices may cause harmful interference with the TPM System and create undesired operation. This Article was created to advise Technicians to be aware of the potential issue. Examples of those After Market devices that generated or blocked radio frequency energy are:

LED Sidemarkers Clear Set For 15-20 Dodge Charger Diode Dynamics
