NUMBER: 08-050-21 REV. A

UHN Radio Enhancements

This bulletin involves updating the radio software level to R17P.2.

2021 (MV) Jeep Compass (Italy/PHEV)

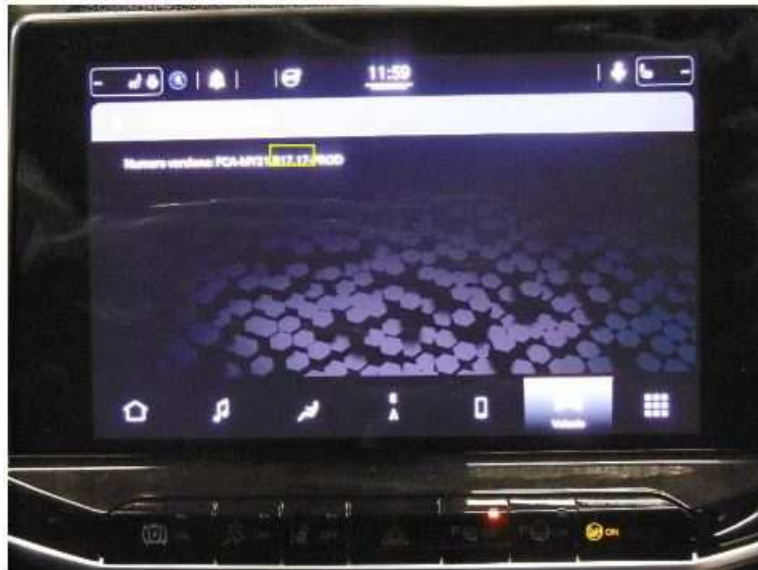
Fig. 3
Software Version

4. Check what the software level is at (FCA-MY21.R17.17-PROD) (Fig. 3) .

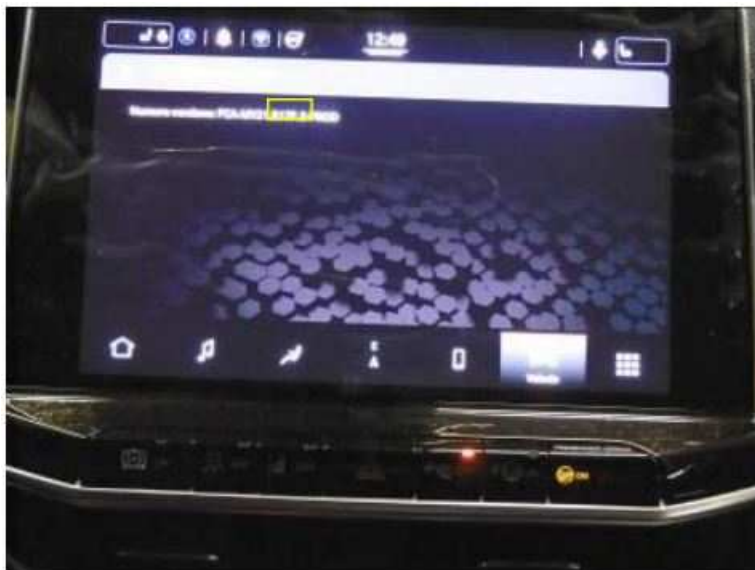
Fig. 15
Software Version

27. Check what software level the radio is at (FCA-MY21.R17P.2-PROD) (Fig. 15) .
