NUMBER: 23-014-21 GROUP: 23 - Body DATE: April 13, 2021

Soft Top Wear Due To Contact With Number Two Bow Side Frame Link

2018 - 2021 (JL) Jeep Wrangler

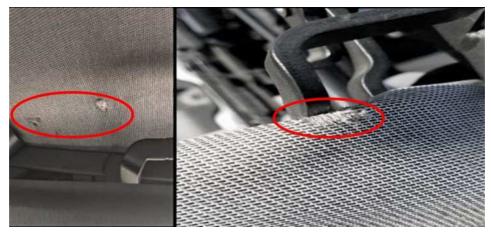
- 1. Visually inspect both the left and right sides of the soft top and soft top cover fabric, when the top is used or stored in the Sunrider position, for contact with the **number two bow** frame for wear and or holes.
- 2. Was any wear on the cover fabric noticed (Fig. 1)?
  - YES>>> Proceed to Step 3.
  - NO>>> This bulletin does not apply. Normal diagnosis should be performed.

Fig. 1 Example Holes And Wear In Cover Fabric

- 3. Using an alcohol wipe or equivalent, clean both the left and right side frame links (Fig. 2) and allow it to air dry.
- 4. Apply anti-wear tape to both the left and right side frame links (Fig. 2) .
