NUMBER: 08-070-21

GROUP: 08 - Electrical

DATE: April 29, 2021

ULQ Radio Enhancements

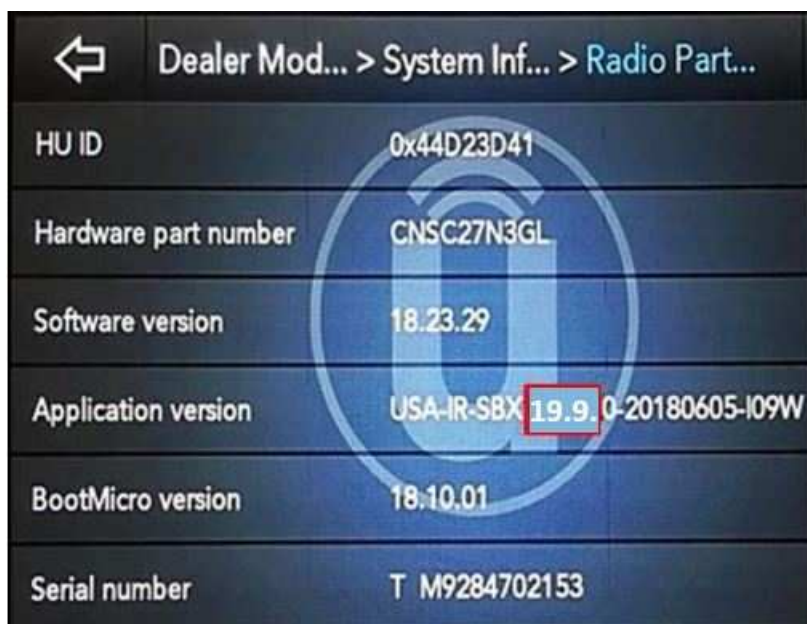
Fig. 1
Radio Software Level Screen

1. Verify the radio software version. Radio must be in Dealer Mode to verify by following these steps:
 - a. Press and hold both lower corners of the display screen, until the Dealer Mode screen appears (approximately seven seconds). Release screen.
 - b. Select "Radio Part Information". The software version will be listed next to "Application Version" (Fig. 1) .

2. What is the radio software level (Application Version) at?
 - ****34.2 or higher >>>** The radio software is already up to date. Normal diagnostics should be performed.

- **Lower than 19.9 >>>** This bulletin does not pertain. Normal diagnostics should be performed.
- **At or above 19.9 >>>** Performed the software updated. Proceed to [Step 1](#) of the Repair Procedure.**

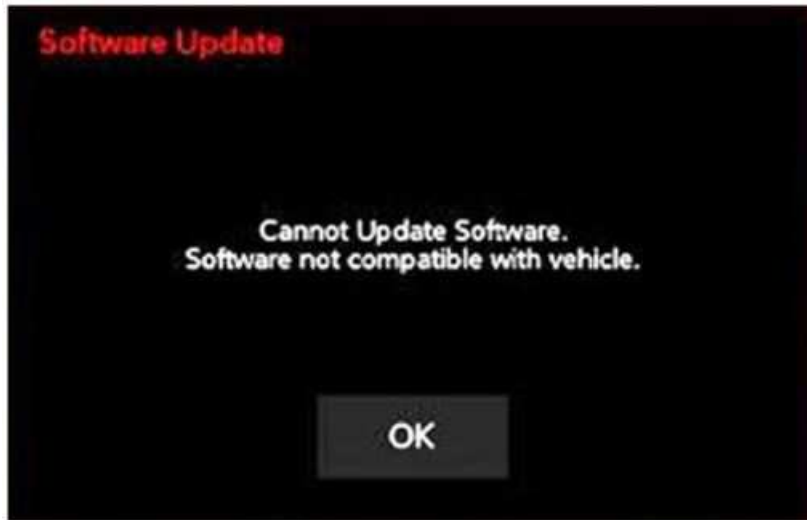
Fig. 5
Software Not Compatible Screen

11. If the screen in (Fig. 5) is displayed, the USB flash drive was not set up correctly. Use a top name brand USB flash drive, like Kingston, create a new USB flash drive and start the update again.

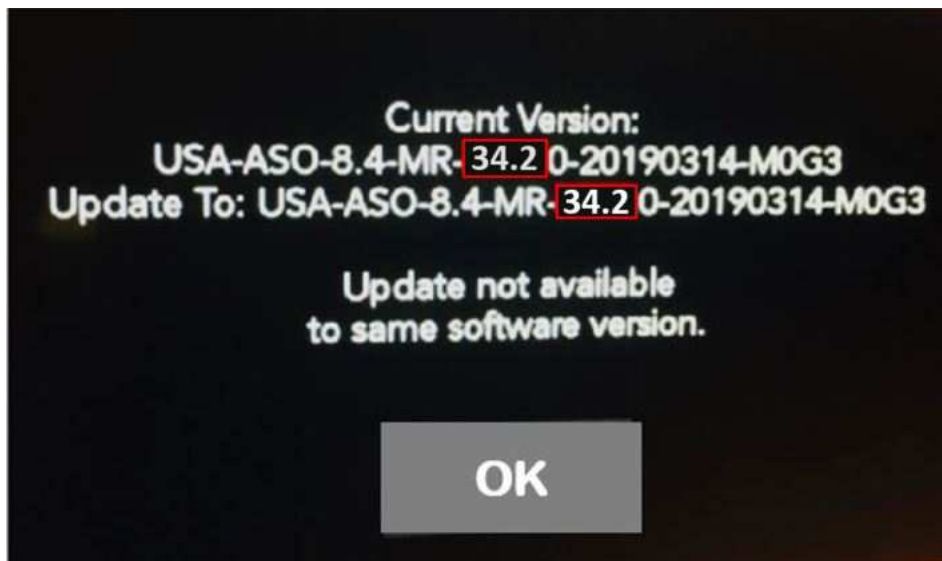
Fig. 6
Screen Displayed When Radio Software Level Is Up To Date

12. If the radio software is already up to date, the screen in (Fig. 6) will be displayed. Press "OK" and remove the USB flash drive.

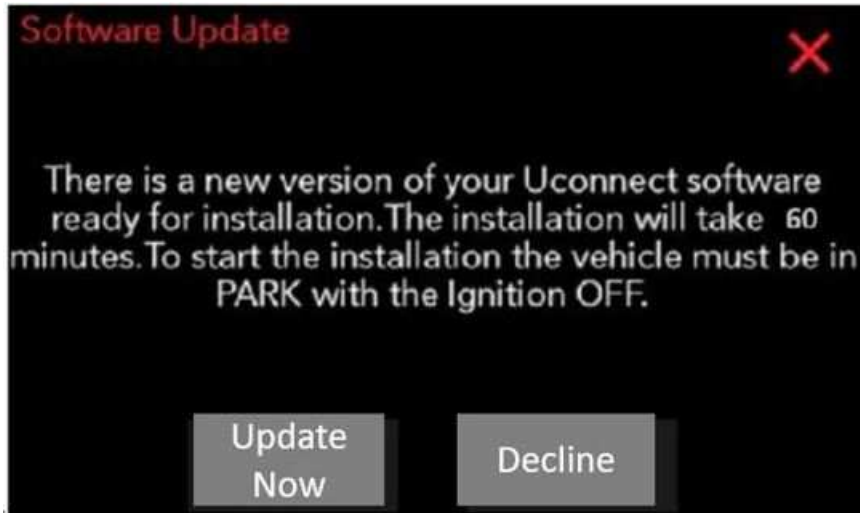
Fig. 7
Software Update Is Available

13. Once the system has verified there is an available update, press the “Update Now” button. Make sure the vehicle is in park, **DO NOT** turn off the ignition (Fig. 7) .

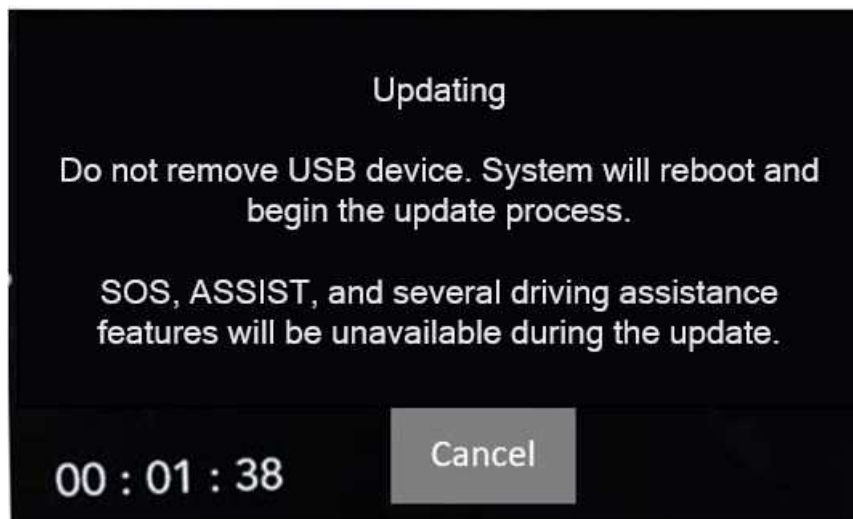
Fig. 8
Updating Screen

14. When the radio starts updating, the screen in (Fig. 8) will be displayed.

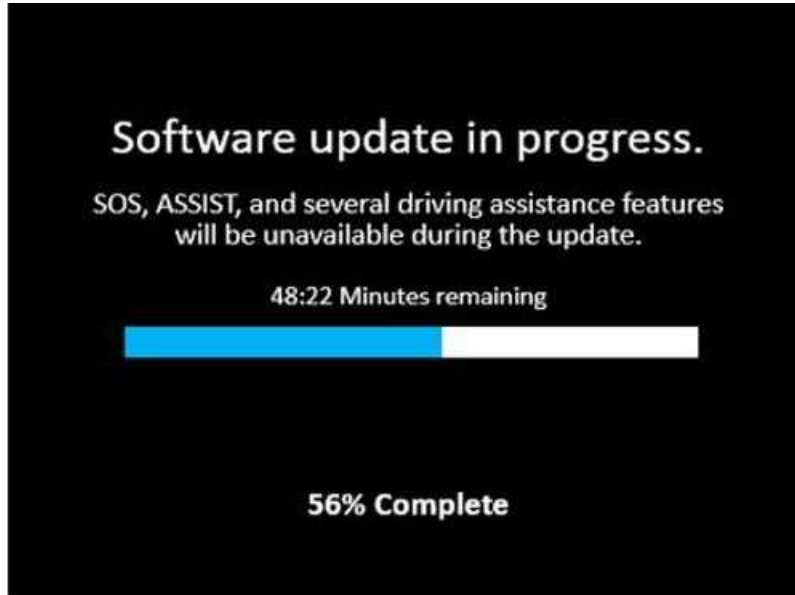
Fig. 9
Software Update In Progress

15. The radio will reboot and the update will begin. The update should only take 25 minutes, the timer on the screen may display the incorrect time remaining, (Fig. 9) .

NOTE: The completion indicator may not reach 100%, even though the software update has been completed. Once the software update has finished, the radio and display screen will turn off.

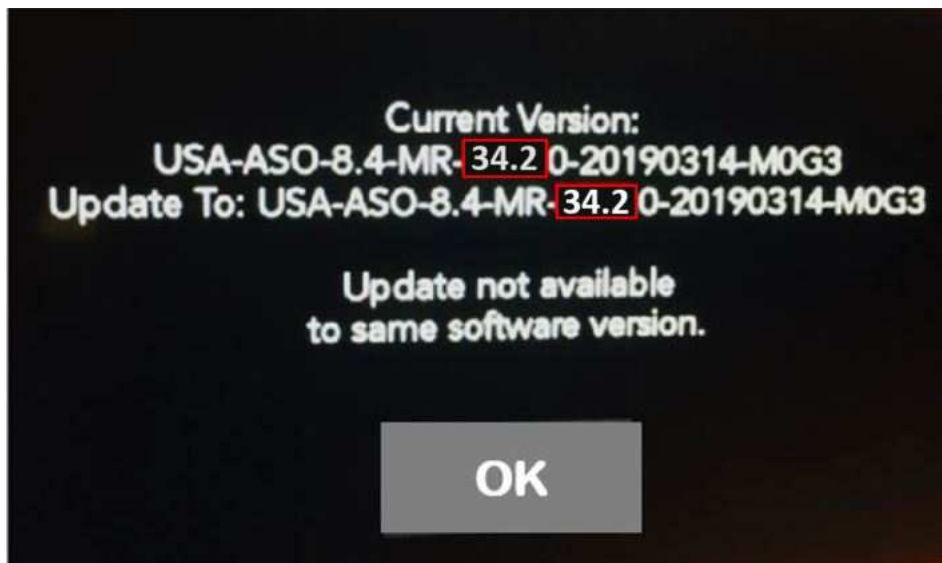
Fig. 10
Radio Software Has Been Updated

16. After the update has completed, the radio will shut down. With the USB flash drive still inserted in the USB port, cycle the ignition back to the run position. If the radio software was updated correctly the "Current Version:" and the "Update To:" software levels in (Fig. 10) will display the identical software level. Press "OK" and remove the USB flash drive.
