Service Bulletin

Bulletin No.: 20-NA-233

Subject: Long Range Radar Setting DTC U3000 49

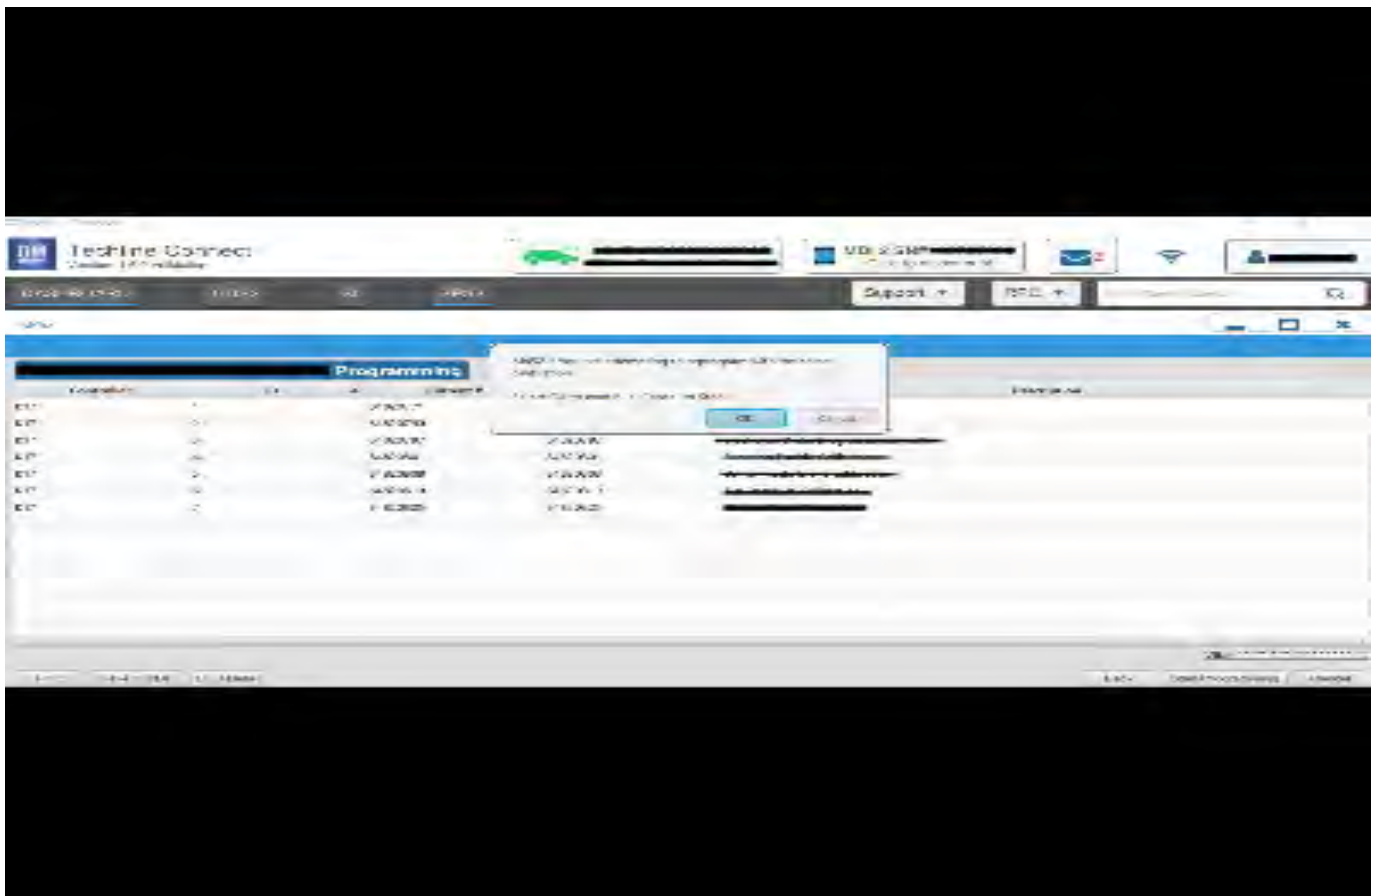
5644477

Caution: Be sure the VIN selected in the drop down menu (1) is the same as the vehicle connected (2) before beginning programming.

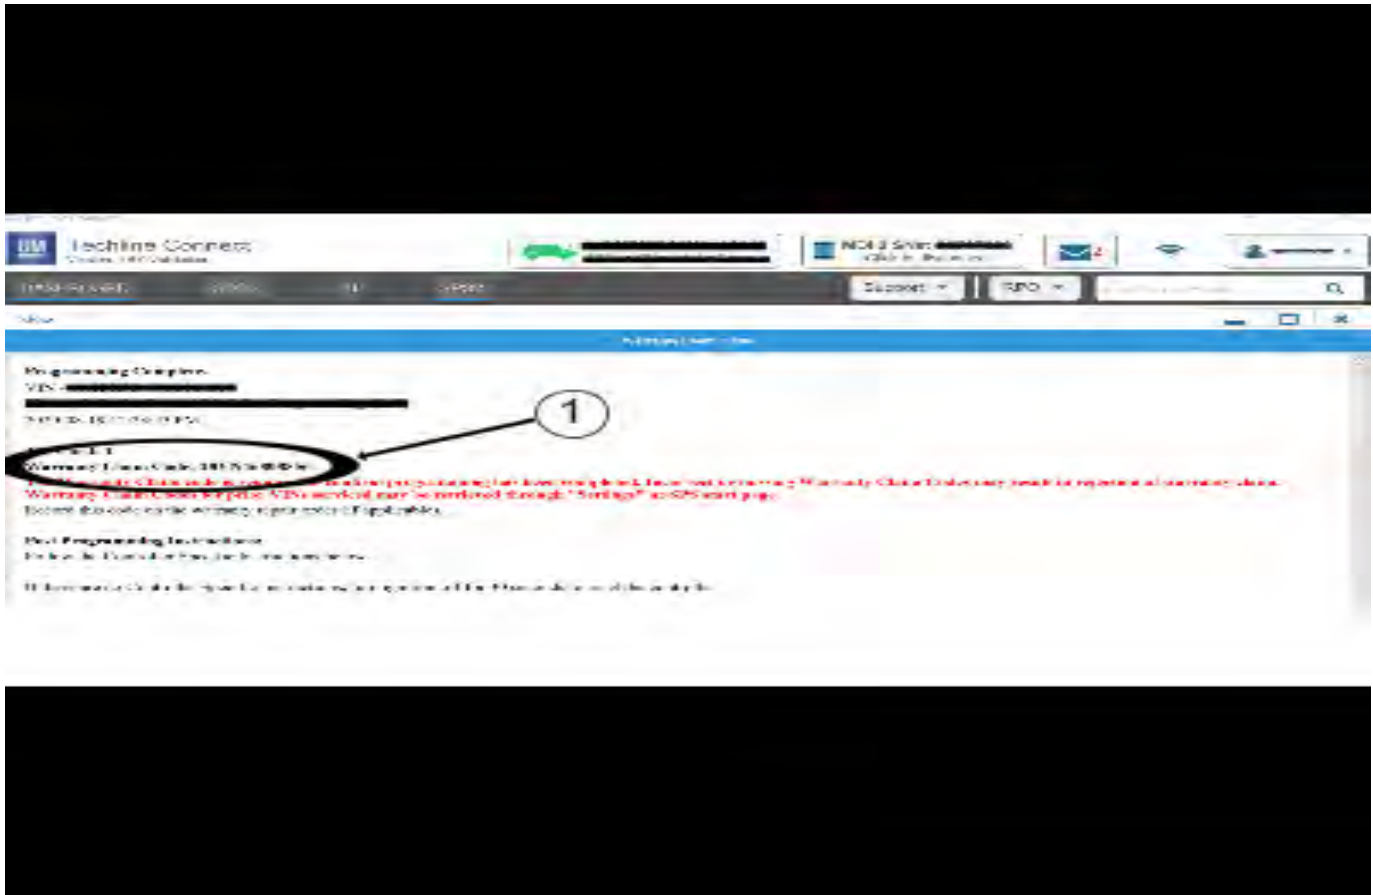
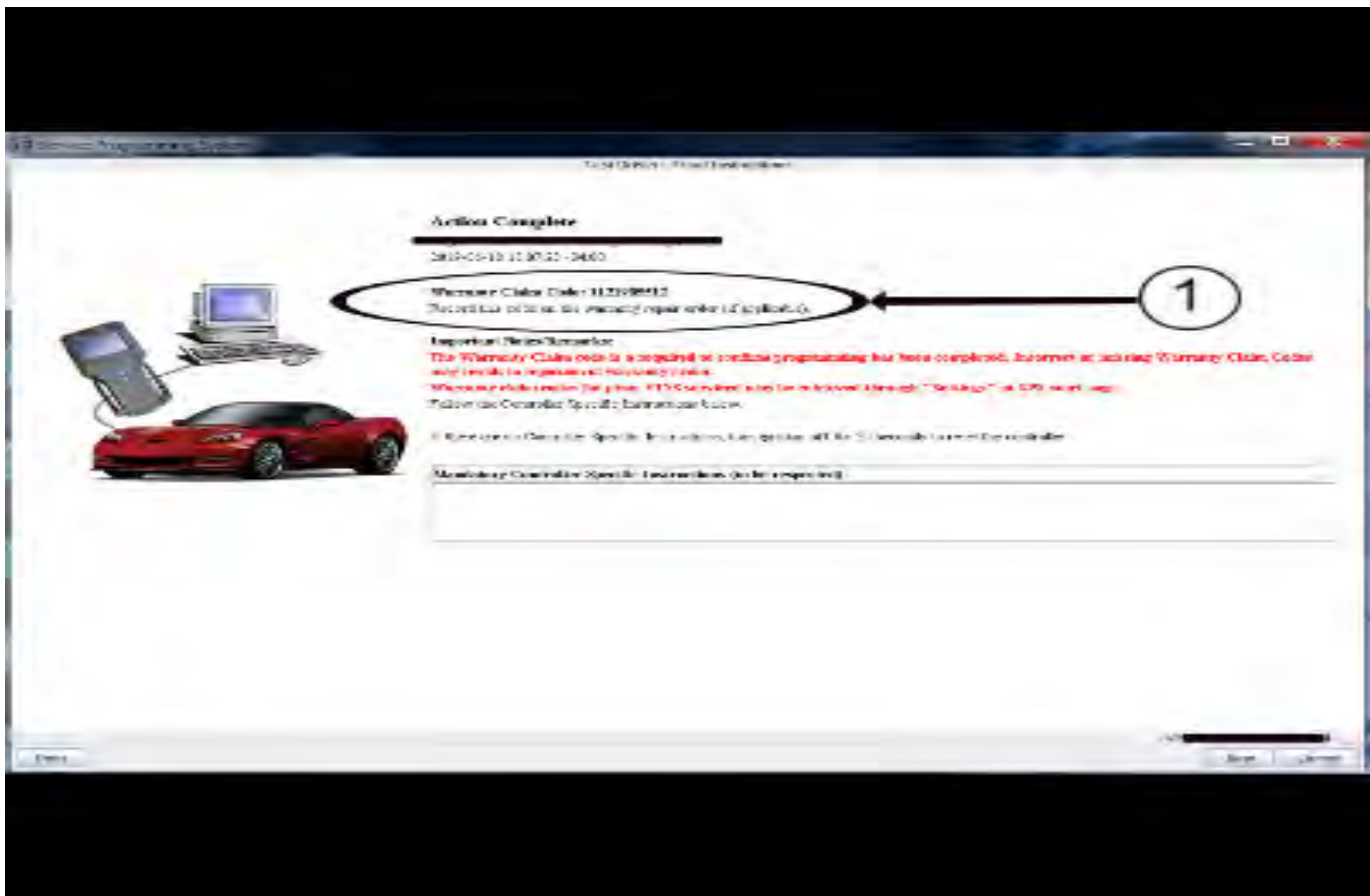
5431209

Important: To avoid warranty transaction rejections, you **MUST** record the warranty claim code provided on the SPS Warranty Claim Code (WCC) screen shown above on the job card. Refer to callout 1 above for the location of the WCC on the SPS screen.

2. Record the SPS Warranty Claim Code on the job card for warranty transaction submission.
