Service Bulletin

Bulletin No.: 21-NA-016

Subject: Malfunction Indicator Lamp (MIL) Illuminated – DTC P00C7, P0236 and/or P1101 Set

Brand:	Model:	Model Year:		VIN:		Engine:	Transmission:
		from	to	from	to		
Buick	Encore GX	2020	2020	—	—	1.3L Turbo (L3T)	—
Chevrolet	Trailblazer (VIN M)	2021	2021

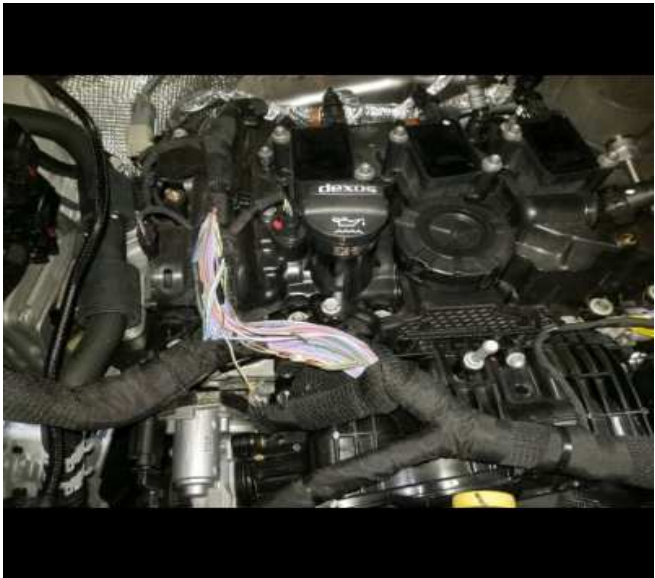
<p>This condition may be caused by a poor crimp retention at splice J113 in the engine harness.</p> <p>– Poor crimp retention may allow circuit 548 to skew the turbocharger boost sensor data.</p>
