# Service Bulletin

Bulletin No.: 21-NA-058

**Subject:** Radio Software Version 382 Update

| Brand: | Model: | Model Year: | | VIN: | | Engine: | Transmission: |
|---|---|---|---|---|---|---|---|
| Cadillac | Escalade | 2021 | 2021 | — | — | — | — |

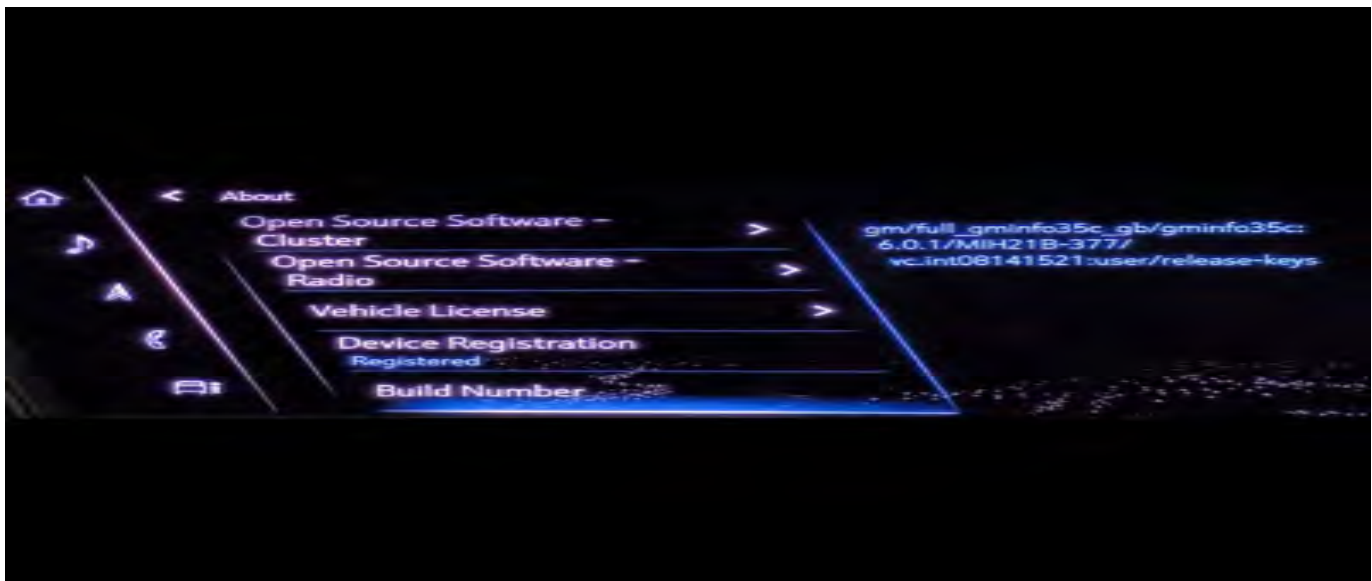
5766434

**Important:** It is important to ensure that the technician is inspecting the full information found within *Build Number*. To identify the current software installed in the radio requires the user to locate the *Build Number* to view the full software version file name. In the middle of this long file name look for 382. (The illustration below shows software version 377, thus that would be outdated.) The number would be numerically lower if the radio is not up-to-date, or numerically higher if newer versions were released and installed.

1. Inspect the current radio software version. Navigate to Settings -> About -> Build Number to view and verify the software version.
  - If equal or greater than 382, this bulletin does not apply. Refer to SI for diagnostics.
  - If less than 382, update the radio software via USB. Refer to *A11 Radio: Programming and Setup* in SI.

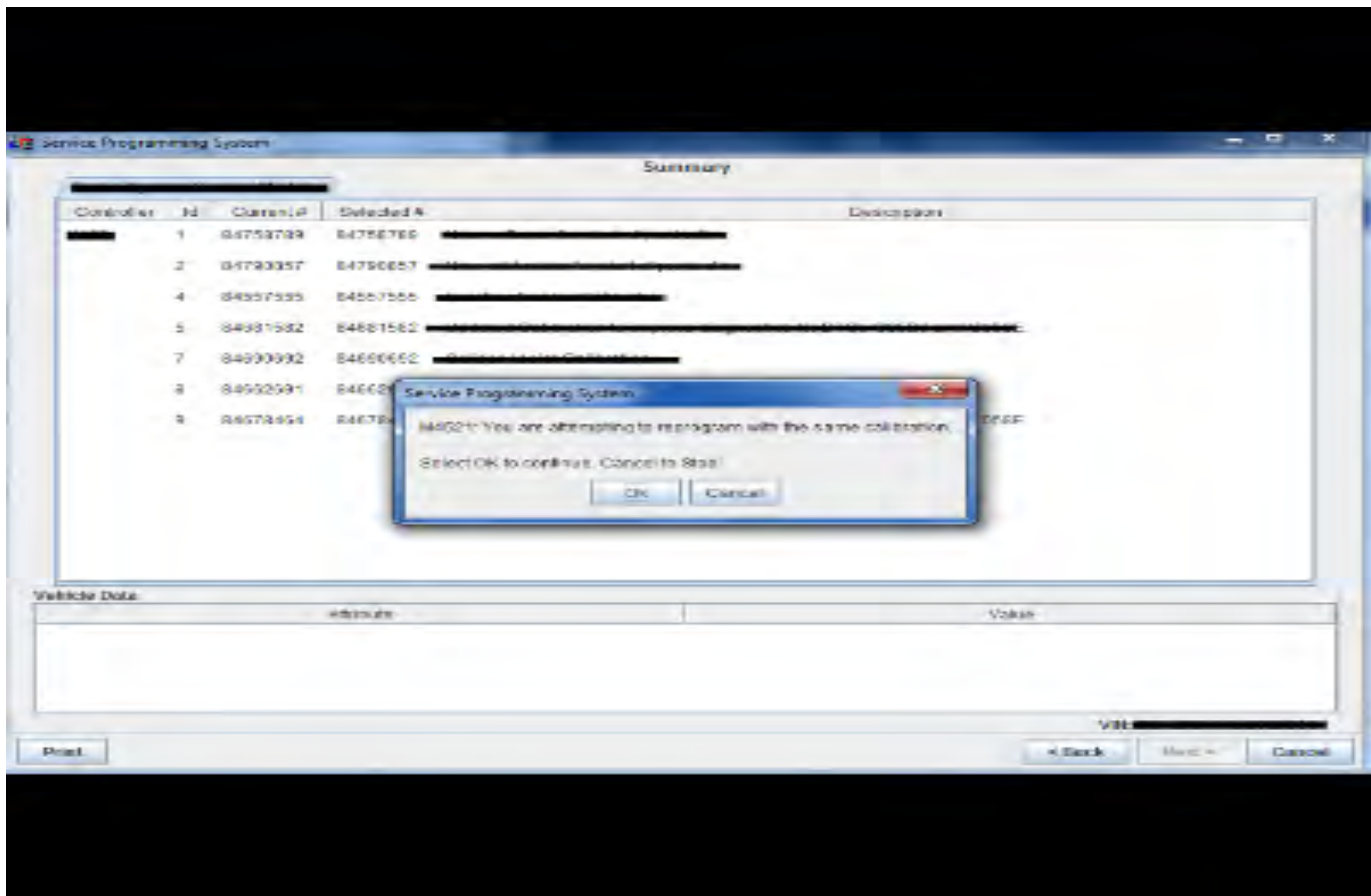
**Caution:** Be sure the VIN selected in the drop down menu (1) is the same as the vehicle connected (2) before beginning programming.

**Important:** Techline Connect and TIS2WEB screens shown above.

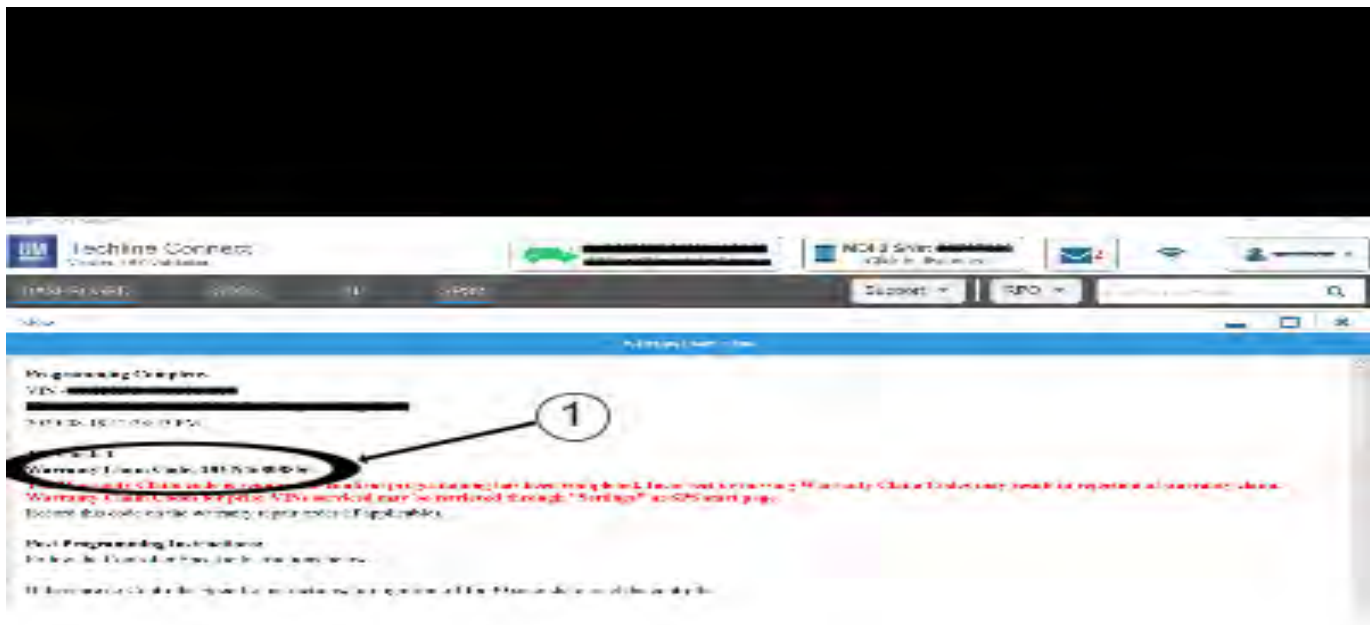
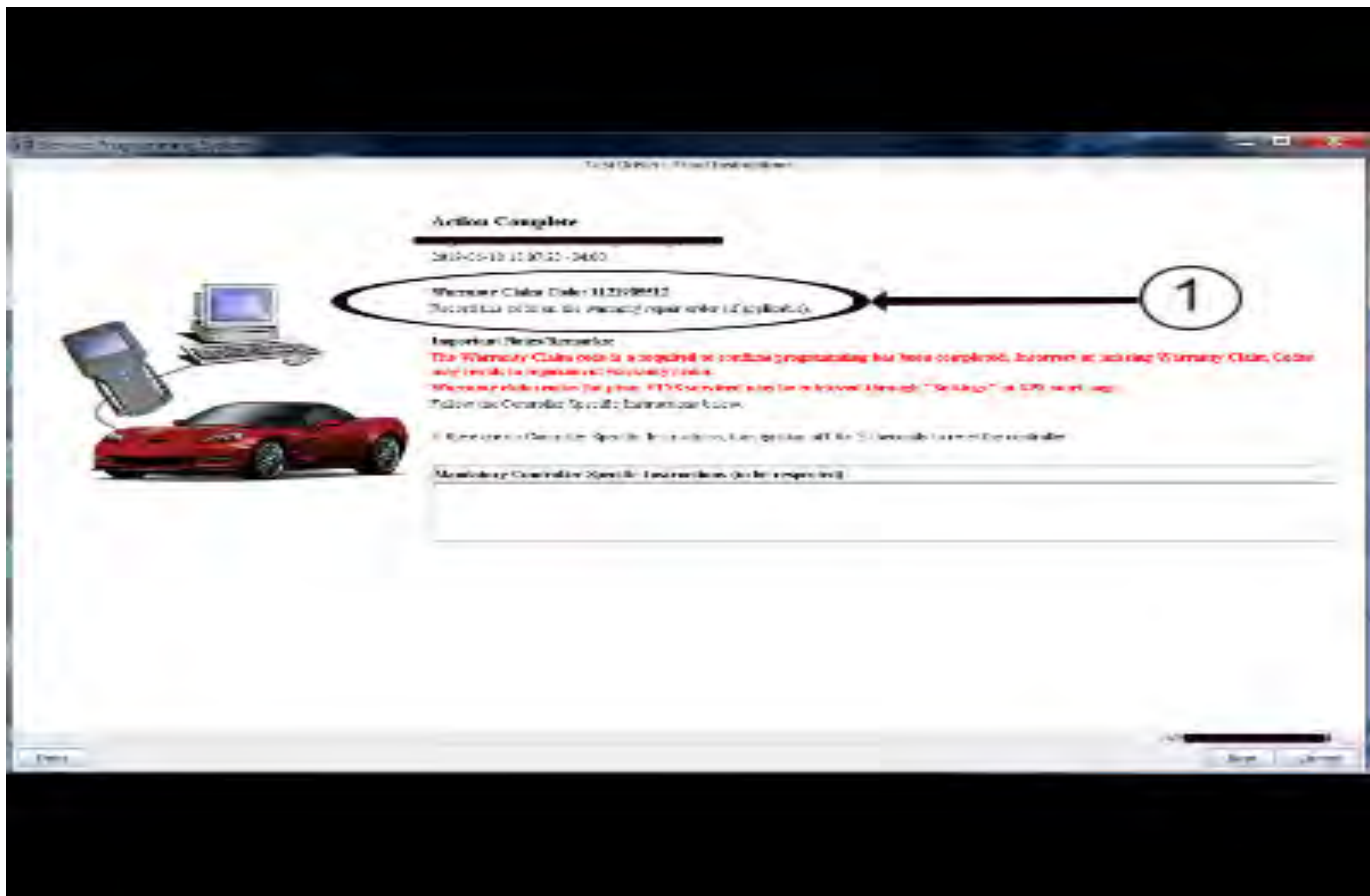
**Note:** The screenshots above are an example of module programming and may not be indicative of the specific module that is being programmed. Module selection and VIN information have been blacked out.

**Important:** To avoid warranty transaction rejections, you **MUST** record the warranty claim code provided on the SPS Warranty Claim Code (WCC) screen shown above on the job card. Refer to callout 1 above for the location of the WCC on the SPS screen.
