Service Bulletin

Bulletin No.: 21-NA-066

Subject: Vehicle No Start, Grinding/Starter Free Spinning Noise Under Hood, Issues During an Auto-Stop/Start Operation

Brand:	Model:	Model Year:		Breakpoint Date:		Engine:	Transmission:
		from	to	from	to		
Buick	Enclave	2019	2020	February 1, 2019	January 1, 2020	LFY	
Chevrolet	Traverse

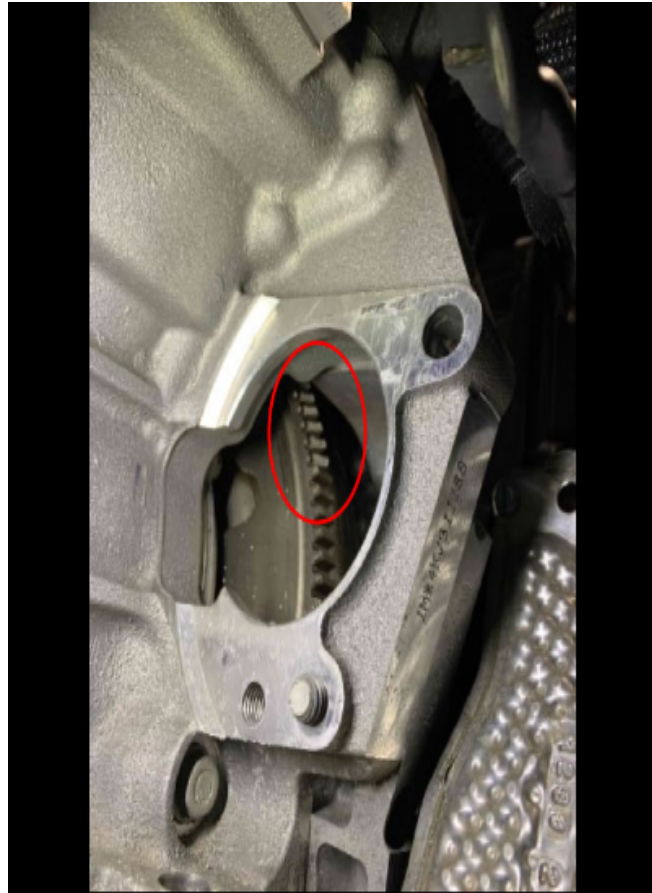
5778556

1. Remove the starter and inspect the flex plate through the starter mounting hole. Inspect by slowly rotating the crankshaft and look for damaged or missing flex plate teeth.
⇒ If any teeth are damaged or missing, replace the flex plate.
Note: If the flex plate teeth are damaged, use the flex plate as the causal part number to replace the flex plate and the starter.
2. Inspect the starter pinion for any damage on the teeth. Inspect all pinion teeth by rotating the starter pinion.

Refer to *Automatic Transmission Flex Plate Replacement* in SI.

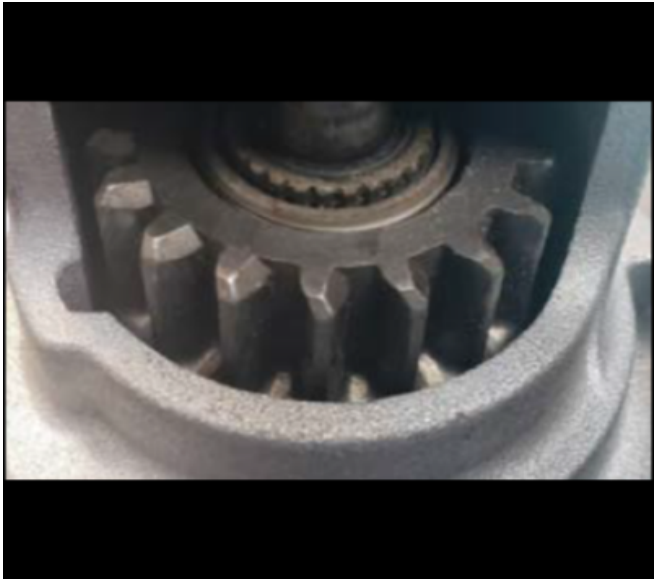
<p>5778557</p> <ul style="list-style-type: none"> - Do not replace the starter if no damage to the pinion teeth is observed as shown in the graphic above. - Starter pinion teeth damage is normally caused by broken/damaged flex plate teeth.
