# Service Bulletin

Bulletin No.: 21-NA-069

**Subject: Buzz or Rattle Type Noise Heard Coming from A-Pillar Area**

Brand:	Model:	Model Year:		VIN:		Engine:	Transmission:
		from	to	from	to		
Cadillac	Escalade Models	2021	2021			All	All

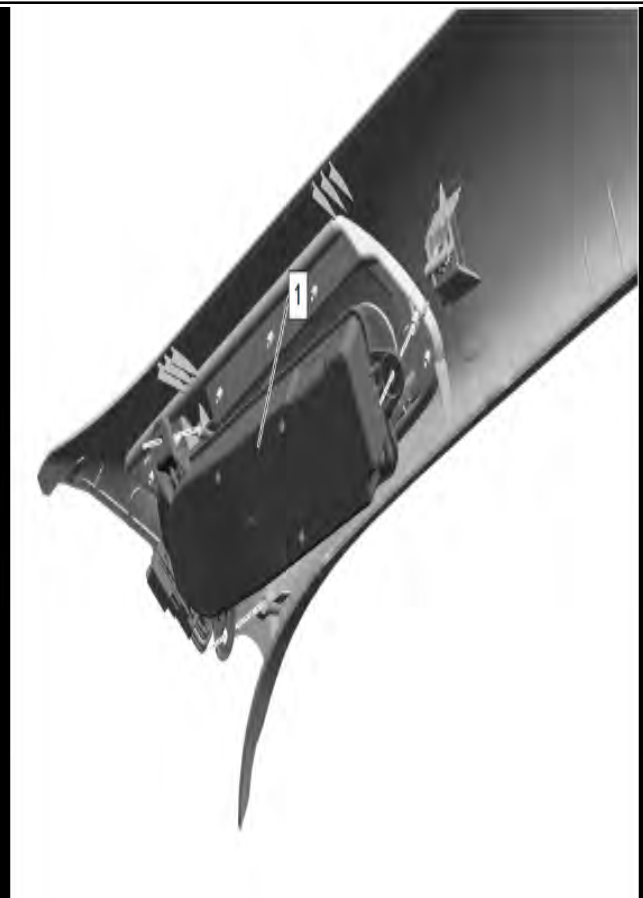
<b>Involved Region or Country</b>	North America, Saudi Arabia, Korea, Russia, Middle East, Japan and S. Korea.
<b>Additional Options (RPOs)</b>	
<b>Condition</b>	Some customers may comment on hearing a buzz or rattle type noise heard coming from the A-Pillar area. The noise could be heard coming from either side of the vehicle.
<b>Cause</b>	The cause of the condition may be due to a manufacturing process error in which a loose screw has become lodged in the radio speaker.

<p style="font-size: small;">5614373</p> <p>Verify the Condition and replace the affected Radio Windshield Side Garnish Molding Speaker (1) Refer to <i>Radio Windshield Side Garnish Molding Speaker Replacement</i>, in SI.</p>
