Service Bulletin

Bulletin No.: 21-NA-099

Subject: Speaker Noise, or Loss of Bass, or Low / No Output of Audio from Individual Speaker Channels

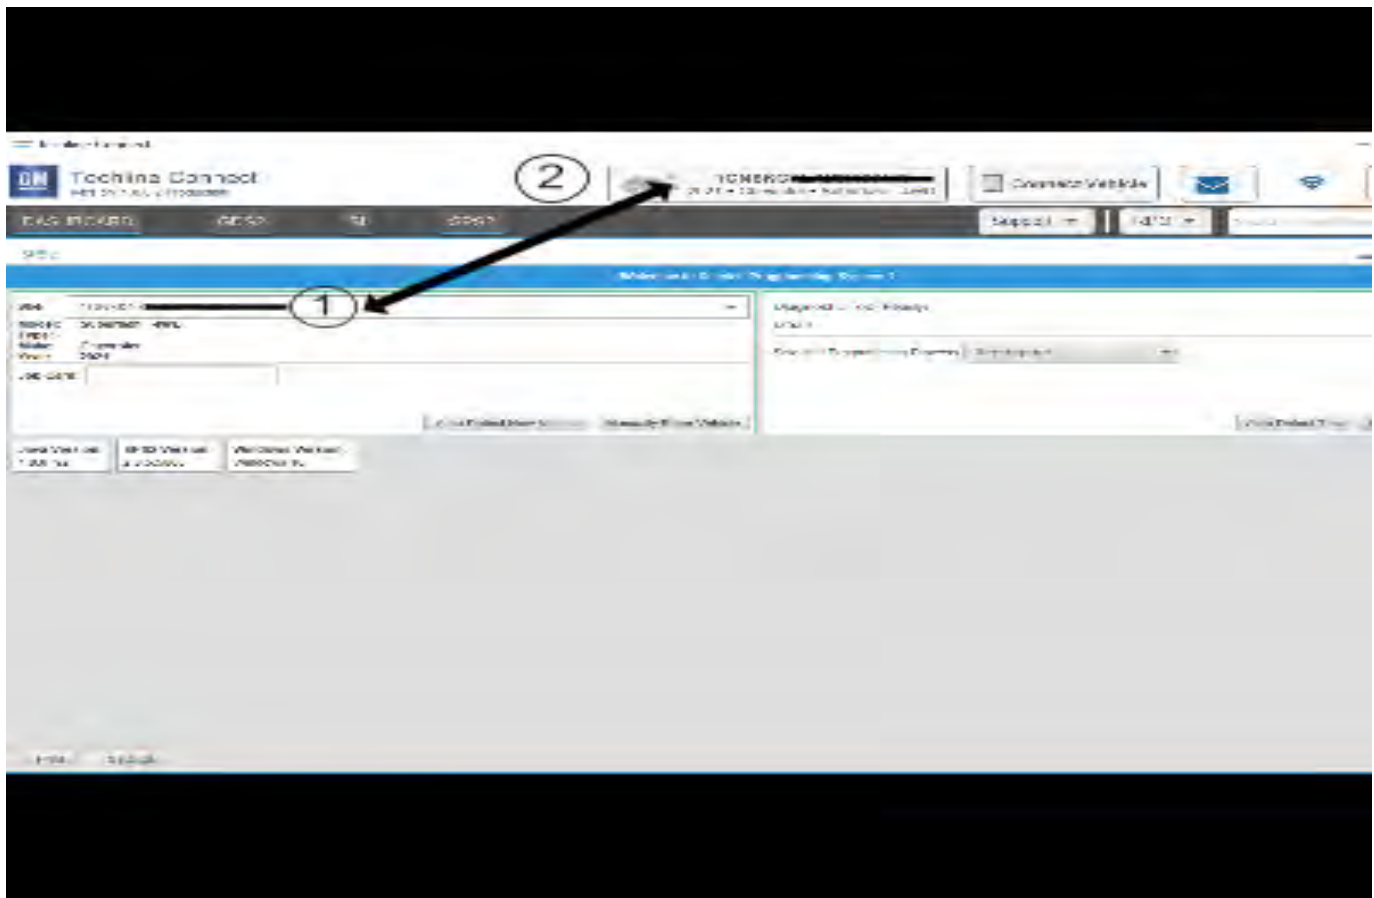
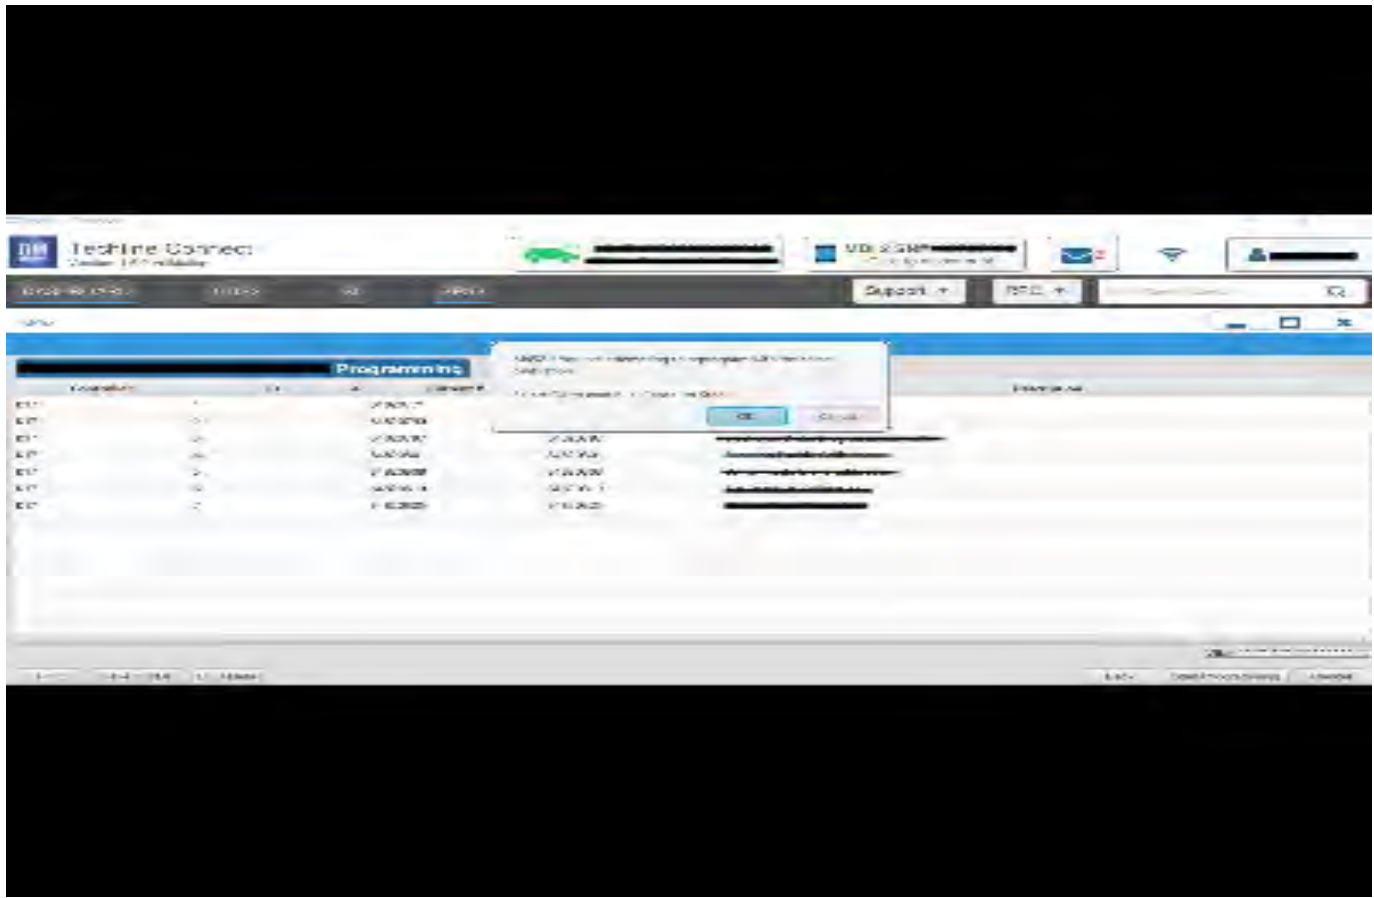
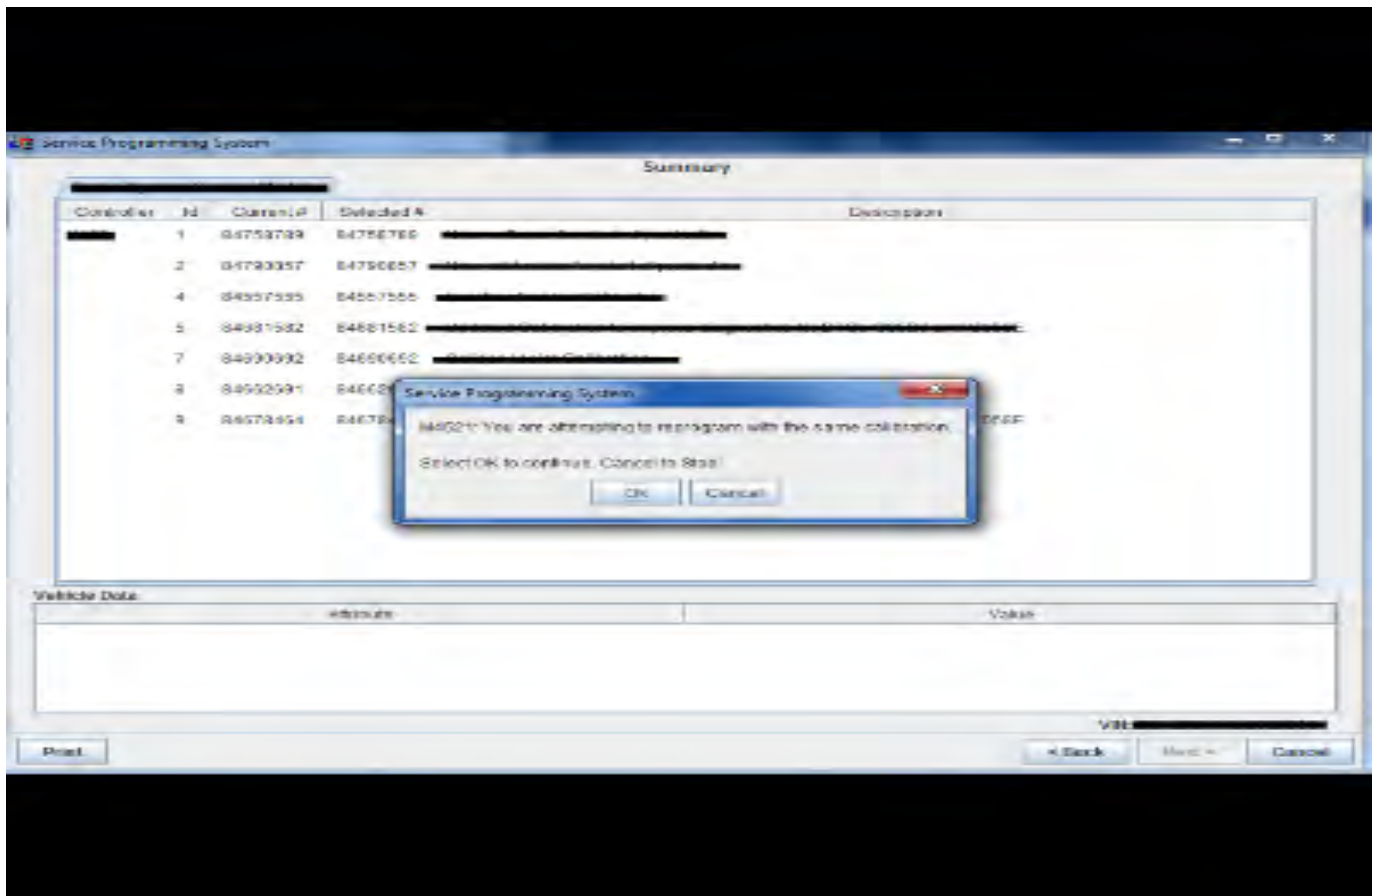
Caution: Be sure the VIN selected in the drop down menu (1) is the same as the vehicle connected (2) before beginning programming.
