Service Bulletin

Bulletin No.: 21-NA-100

Subject: Video Player Unavailable – No SD card present Messages Displayed

Brand:	Model:	Model Year:		VIN:		Engine:	Transmission:
		from	to	from	to		
Cadillac	XT6	2020	2020	—	—	—	—

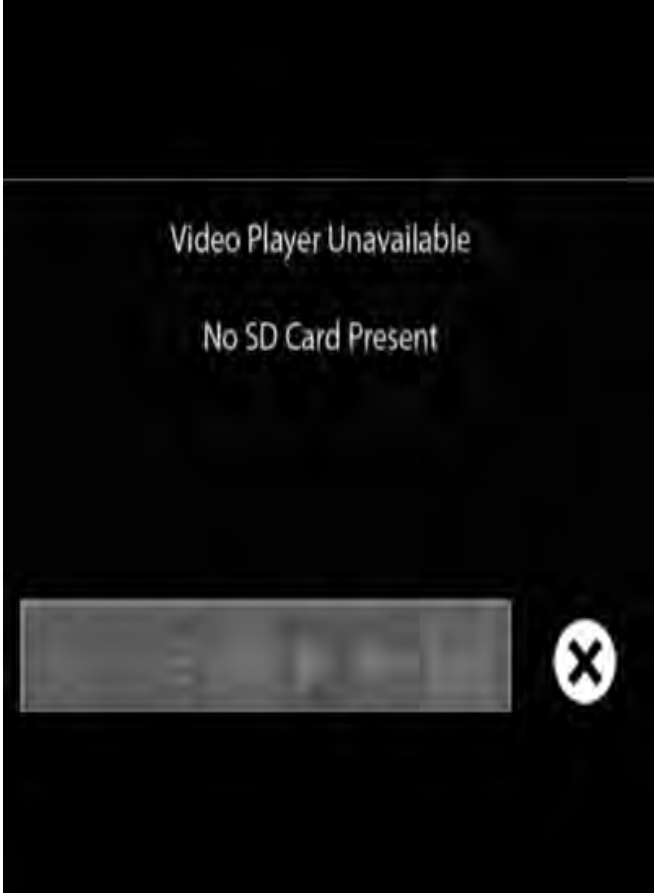
Involved Region or Country	North America, Russia, Middle East, Israel, Japan, Cadillac Korea (South Korea)
Condition	<p>Some customers may comment on the following messages, "Video Player Unavailable" and "No SD Card Present" on the radio display.</p> <div style="text-align: center;">

</div> <p style="text-align: right; font-size: small;">5795667</p>
Cause	The cause of the condition may be software anomalies.
Correction	Reprogram the VPM (Video Processing Module).

1. Reprogram the Video Processing Module. Refer to *K157 Video Processing Control Module: Programming and Setup* in SI.
