Service Bulletin

Bulletin No.: 21-NA-102

Subject: Information on Replacing Hood Latch

Brand:	Model:	Model Year:		VIN:		Engine:	Transmission:
		from	to	from	to		
Chevrolet	Camaro	2016	2018	—	—	All	All

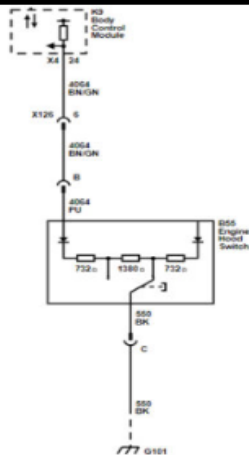
5807138

When replacing the hood latch, the service replacement P/N 84678990 will also require the use of connector P/N 19368220. This new service latch has a three-wire connector, while the original latch P/N 84053842 on Model Years 2016-2018 will only have a two-wire connector.

1. The new connector will come with three leads. The yellow wire needs to remain installed for water intrusion protection. The extra lead needs to be sealed using a DuraSeal splice sleeve and taped back into the harness. Refer to *Wire to Wire Repair* in Service Information (SI) for more information.
2. The schematic document ID: 4673035 in SI shows a purple wire on the latch - on the new connector this is a red wire. Connect the red wire on the connector to the BN/GN wire in the vehicle harness.
3. Connect the black wire on the connector to the black wire on the vehicle harness.
