# Service Bulletin

Bulletin No.: 21-NA-105

**Subject:** Engine Control Module Calibration for DTC P0171 and P0174 Set

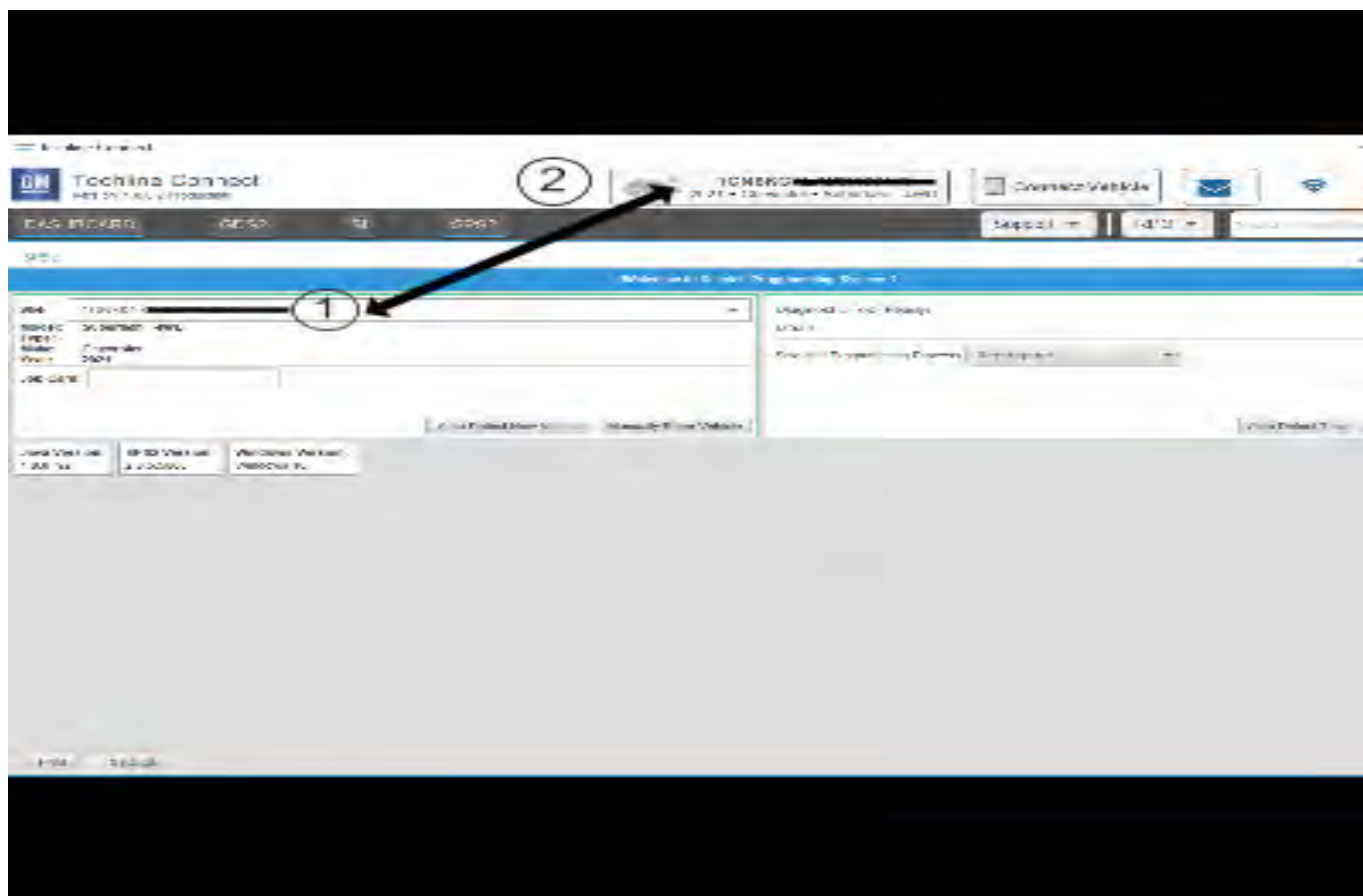
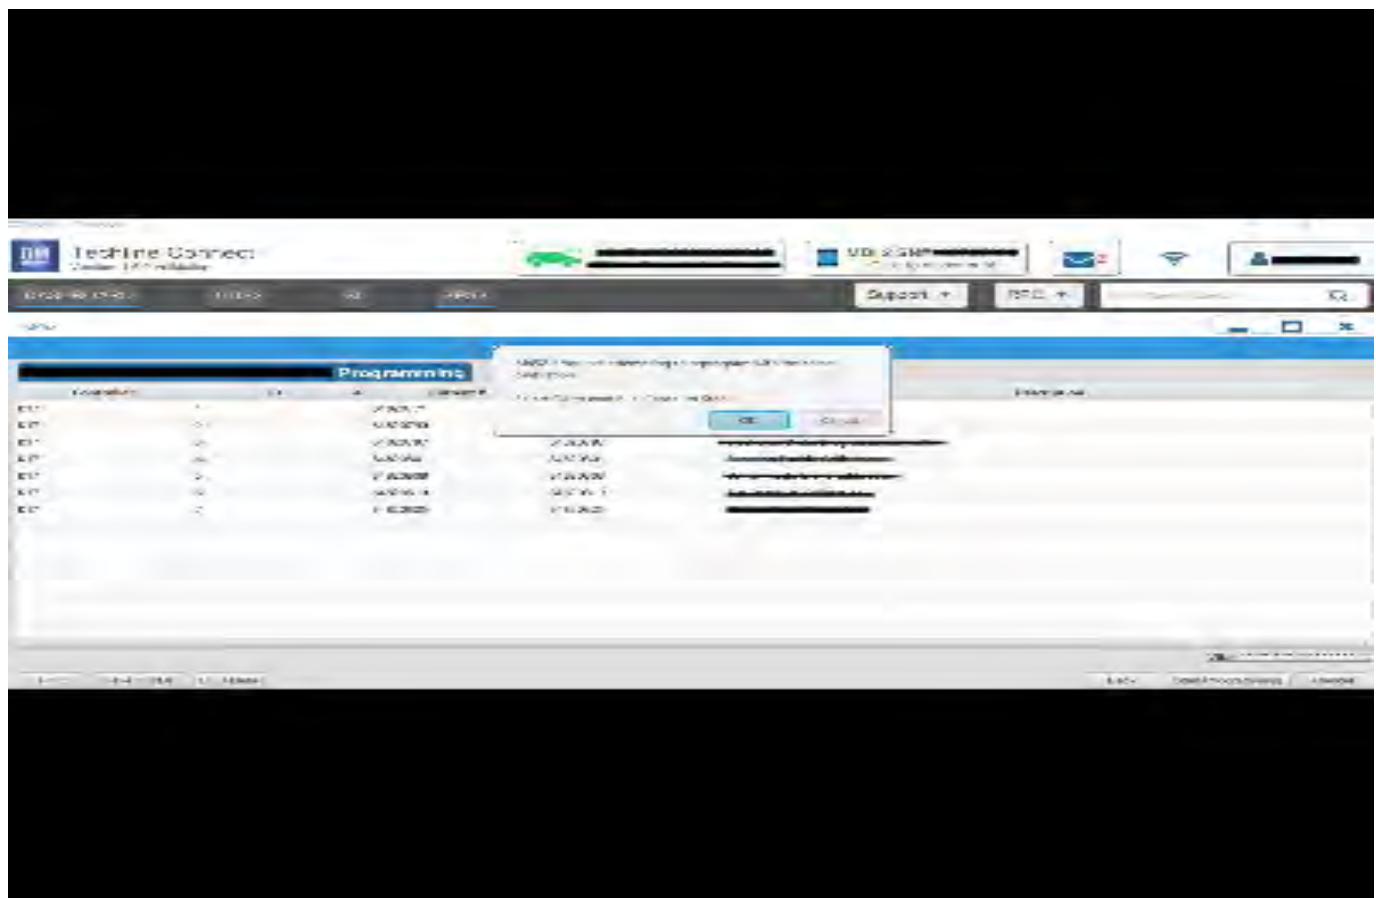
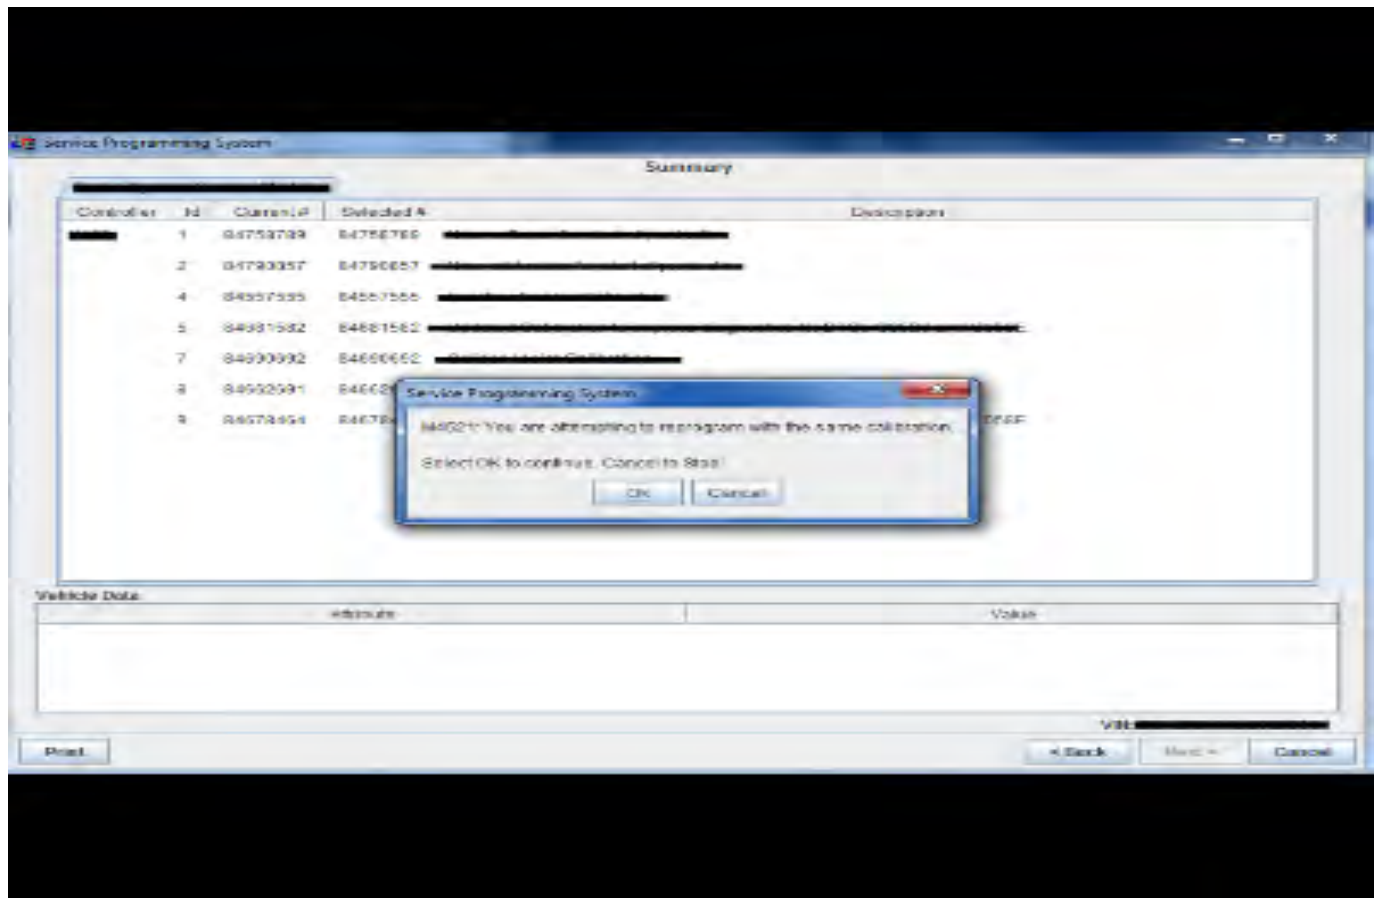
**Caution:** Be sure the VIN selected in the drop down menu (1) is the same as the vehicle connected (2) before beginning programming.
