GLOBAL SAFETY FIELD INVESTIGATIONS
DCS5745
URGENT - DISTRIBUTE IMMEDIATELY

Subject: N212328980 - Service Update
Rear Fuse Block Cover Diagram Has Incorrect Fuse Information

Models: 2021 Chevrolet Equinox
2021 GMC Terrain

N212328980 Rear Fuse Block Cover Diagram Has Incorrect Fuse Information

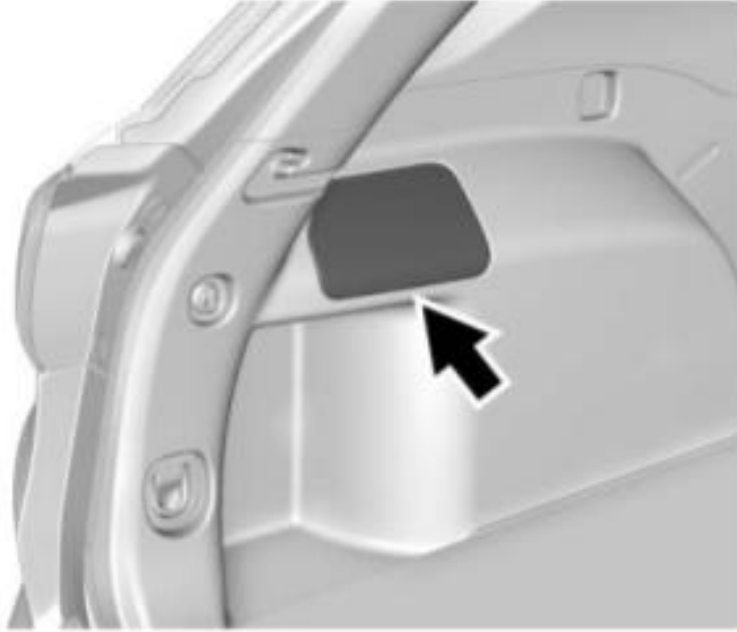
5758252

Condition	Certain 2021 model year Chevrolet Equinox and GMC Terrain vehicles may have a condition where the rear fuse block cover diagram has incorrect fuse values.
Correction	Dealers are to add an adhesive label to the rear fuse box cover.

1. Remove the rear fuse block cover panel, shown here.
2. Clean the area where the label is to be applied using a non-oil-based cleaner such as isopropyl alcohol (rubbing alcohol), Kent Acrysol, P/N 20005, or an equivalent cleaning solvent or adhesive remover.
