Subject: N212331780 - Service Update  
Missing Ground Fasteners

Models: 2021 Chevrolet Tahoe Police Pursuit Vehicle  
Equipped with Radio Suppression Equipment (RPO UN9)

## N212331780 Missing Ground Fasteners

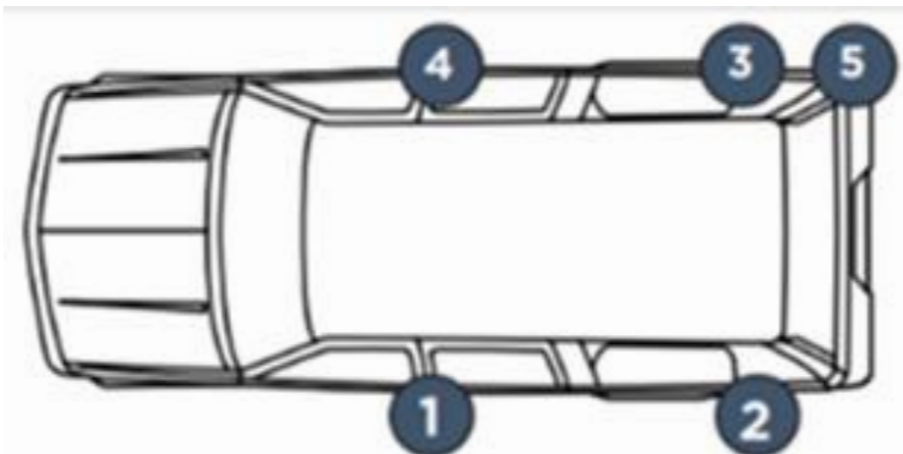
5797615

- Using the above graphic as a guide to ground strap locations, inspect locations 1-4 for a missing bolt/nut or ground strap per the following steps.

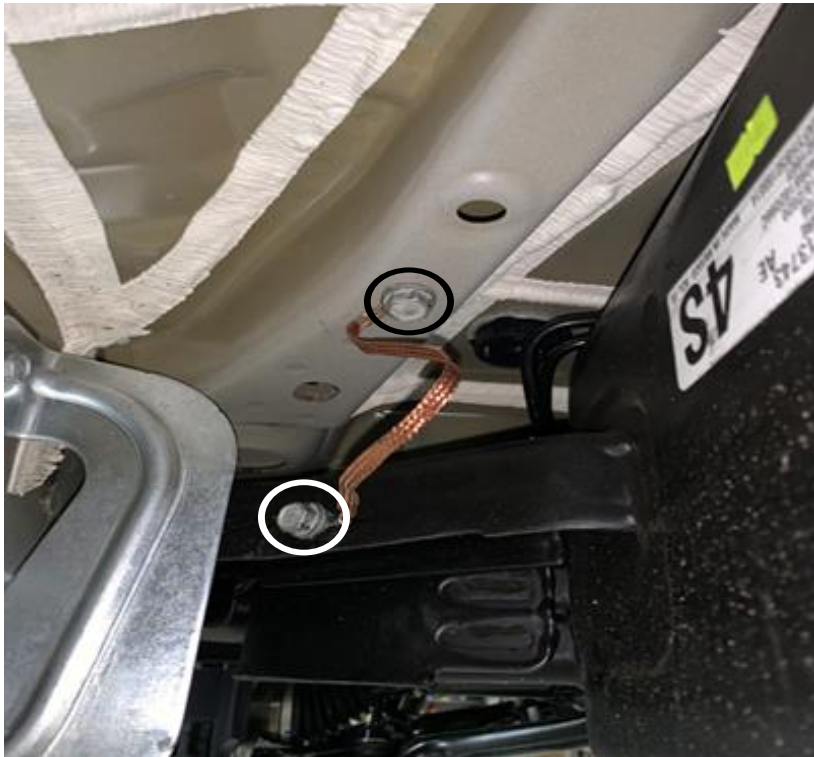
5794301

#### 2. Inspect location 1 – left front.

- If either of the bolts is missing, or the ground strap is not present, install the missing fasteners (and ground strap, if necessary) in that location.
  - If replacing a fastener, torque the body screw to 36 lb.-in (4.0 N-m). Torque the frame bolt/nut to 70 lb-in (8 N-m).
- If the ground strap is present and no bolts are missing, no further action is required at this location. Proceed to the next step.
