GLOBAL SAFETY FIELD INVESTIGATIONS  
DCS5760  
URGENT - DISTRIBUTE IMMEDIATELY

Subject: REVISION – N202325460-02 - Service Update  
Radio Software Update  
Revised the warranty information table.

Models: 2021 Cadillac Escalade and Escalade ESV

## N202325460 Radio Software Update

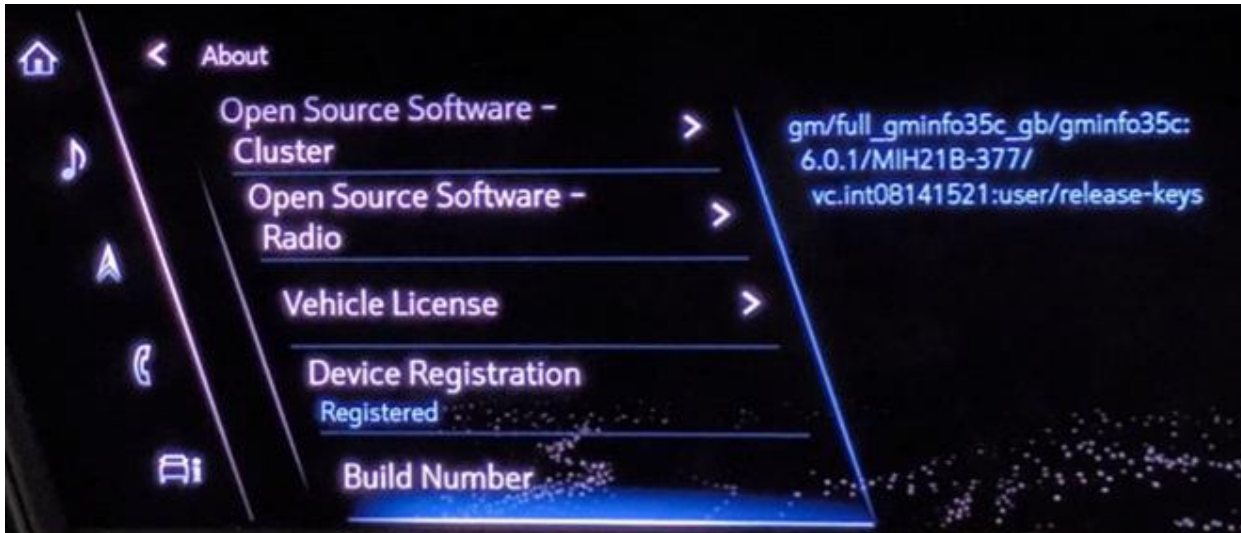
5766434

**Important:** It is important to ensure that the technician is inspecting the full information found within *Build Number*. To identify the current software installed in the radio requires the user to locate the *Build Number* to view the full software version file name. In the middle of this long file name look for 382. (The illustration below shows software version 377, thus that would be outdated.) The number would be numerically lower if the radio is not up to date, or numerically higher if newer versions were released and installed.

1. Inspect the current radio software version. Navigate to Settings -> About -> Build Number to view and verify the software version.
  - If equal or greater than 382, this bulletin does not apply. Close out using the second 'verified module software' labor op. No WCC will be required.
  - If less than 382, update the radio software via USB. Proceed to Step 2.
2. Reprogram the Radio. Refer to *A11 Radio: Programming and Setup* in SI.
