Subject: REVISION: 18226-01 - Special Coverage  
Overheating of Fuel Relay or Motor Terminal  
Revised Service Procedure

Models: 2008-2011 Buick Lucerne  
2009-2011 Cadillac DTS

## 18226 Overheating of Fuel Relay or Motor Terminal

Reference Number: N182155410

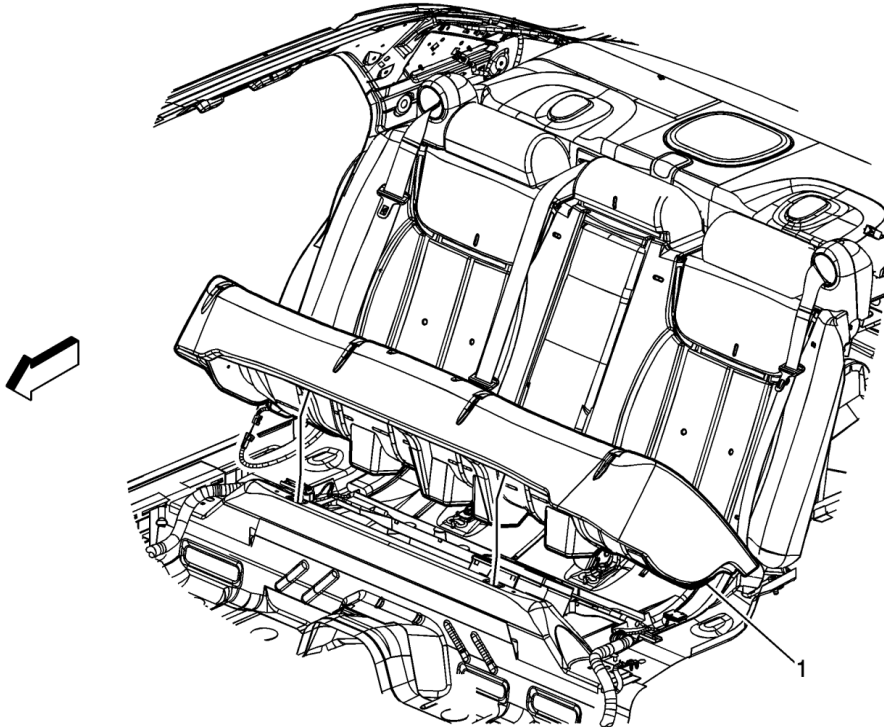
1572099

1. Remove the rear seat bottom cushion (1).
2. Disconnect the negative battery cable.

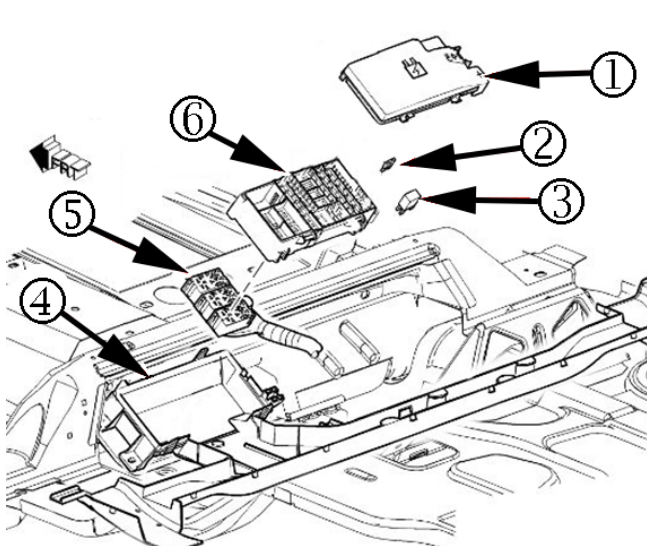
5118028

3. Remove the Rear Electrical Center (REC) cover (1).
4. Inspect the cover for signs of contact with the fuel pump relay.
5. Remove and inspect the fuel pump relay (3) for any signs of contact, damage and/or burn marks.
6. Remove and inspect the fuel pump fuse (2) for any signs of damage and/or burn marks.
7. Separate the upper REC (6) from the lower housing (4) by pressing the 4 locking tabs.
8. Inspect the REC for the following concerns:

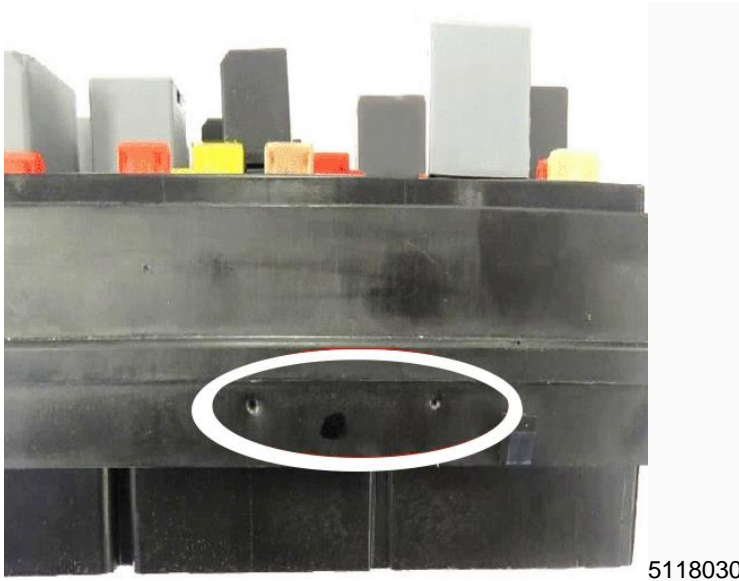
- Contact marks from the seat brackets. (Lucerne Only)

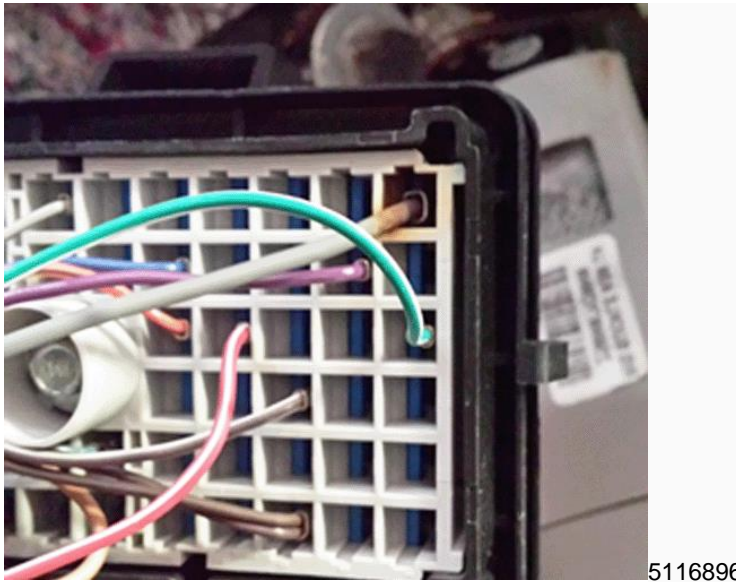
5116896

- Burnt wires or terminals at the F1 cavity.

- Replace the REC.
- Repair the wire terminal at the F1 cavity.
- If required, replace the X1 connector.
- Trim seat brackets. (Lucerne Only)
- Reposition REC. (DTS Only)

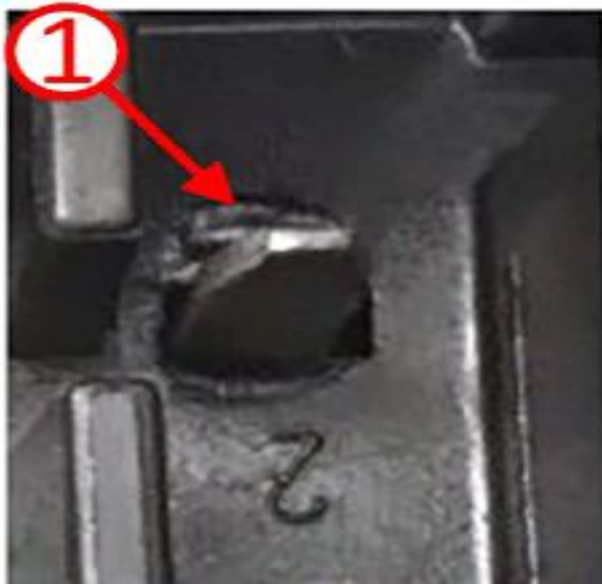
4871373

11. Inspect for any signs of warping or disfigurement caused by heat to the junction block (1).

If no damage is found, **Do Not** replace the fuse block, trim the seat brackets per the applicable section below (Lucerne Only) and refer to SI for further diagnostics.

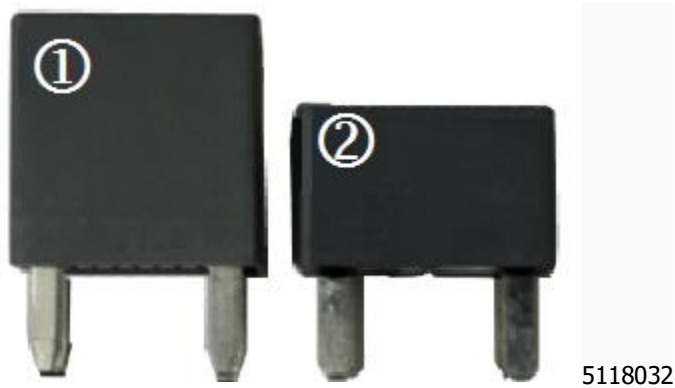
- Determine if vehicle has a tall (1) or short (2) Fuel Pump Relay.
- If the vehicle has a tall Fuel Pump Relay, replace the REC.
- Trim seat brackets. (Lucerne Only)
- Reposition REC. (DTS Only)
