# Aftersales TSO – Diagnostic Sheet

## MAS002453/A (BOL 21-01/A)

### Difficulty opening the doors

**Models:** M156, M57 and M161 from MY18 and later vehicles equipped with "Soft Door Close" (OPT 228, 228+)

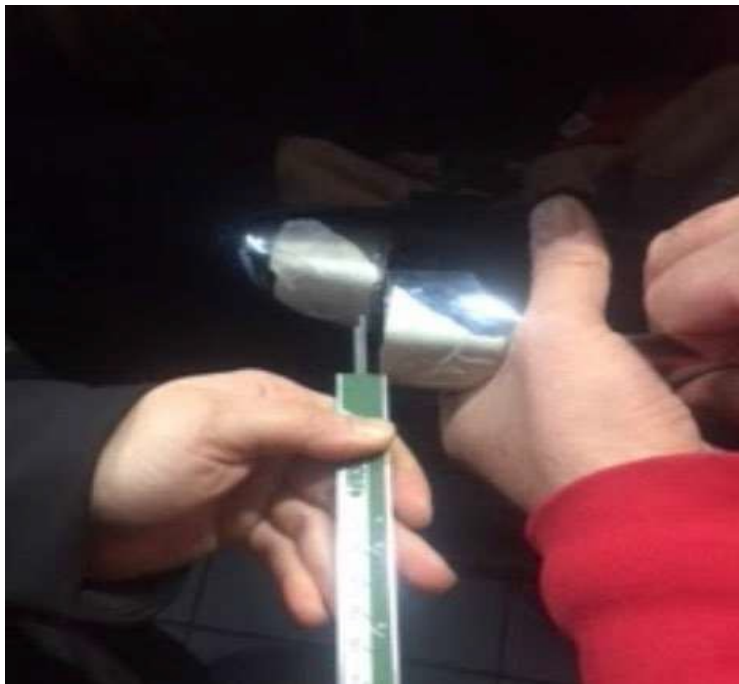
- Slowly pull the handle until the door is unlocked
- Measure the stroke with a caliper, as shown in the following image
