SIB 33 02 21

KNOCKING NOISE FROM THE REAR AXLE OVER UNEVEN ROAD SURFACES

E-Series	Model Description	Production Date
F95	X5 M Sports Activity Vehicle	December 1, 2019 to April 30, 2021
F96	X6 M Sports Activity Coupe	December 1, 2019 to April 30, 2021

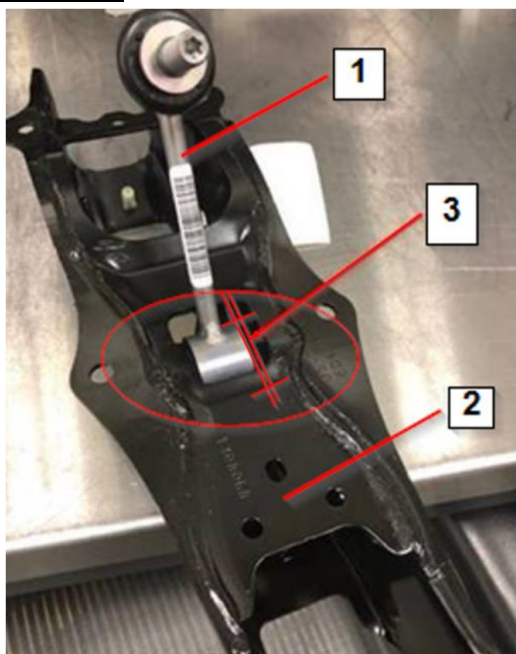
An unfavorable gap (3) may exist between the rear swing support (1, aka sway bar link) and the camber arm (2).

Photo shows components removed from the vehicle for clarity.

If the noise can be reproduced as heard in the video, then the gap between the rear swing support and camber arm must be checked and minimized.

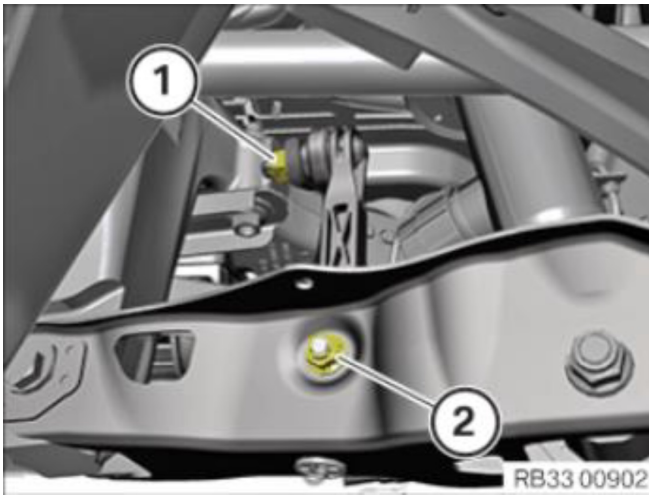
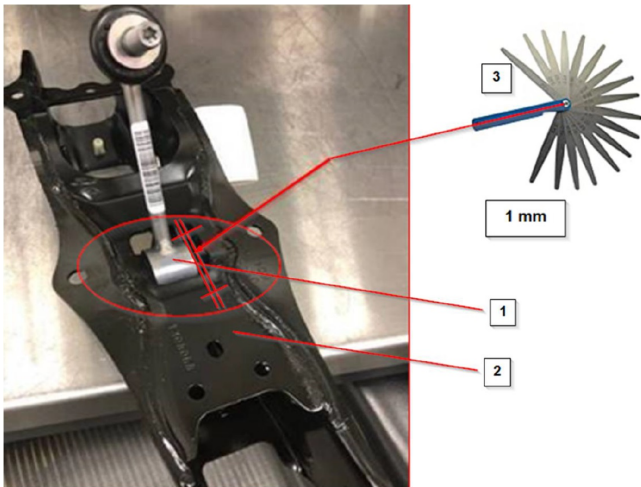
2. Check the gap between the inner sleeve of the rubber mounts on the rear swing support (1) and the camber arm (2) using a feeler gauge (3) to see if a 1 mm space is present.

3. Is the gap greater or equal to 1 mm?

1. Loosen the rear swing support connection (1) on the rear stabilizer bar to allow the swing support to move in the camber arm.

Replace the nuts and tighten as per **REP33 55 041**.
