SIB 54 01 21

SUNROOF REVERSES WHEN CLOSING

E-Series	Model Description	Affected Option Code
G12	7 Series Sedan	Without 402 (Panoramic moonroof)

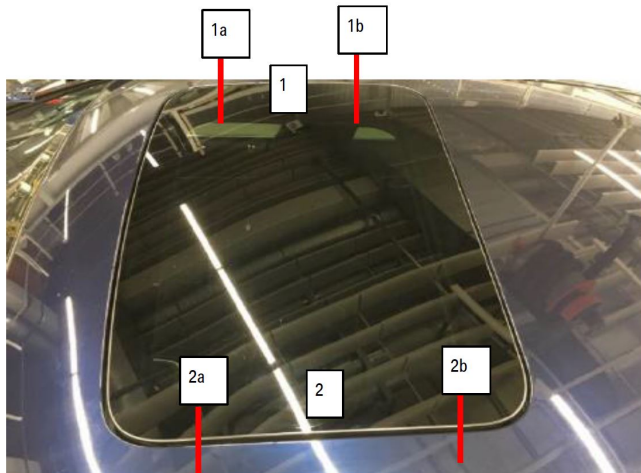
2. Measure the gap between the sunroof glass panel and the roof as shown at 6 points 1a, 1b, 1c, 2a, 2b, 2c.

Gap 1a should match gap 2a.

Gap 1 should match gap 2.

Gap 1b should match gap 2b.

If the gaps measure differently side to side, continue to step 3. Otherwise, continue to step 5.

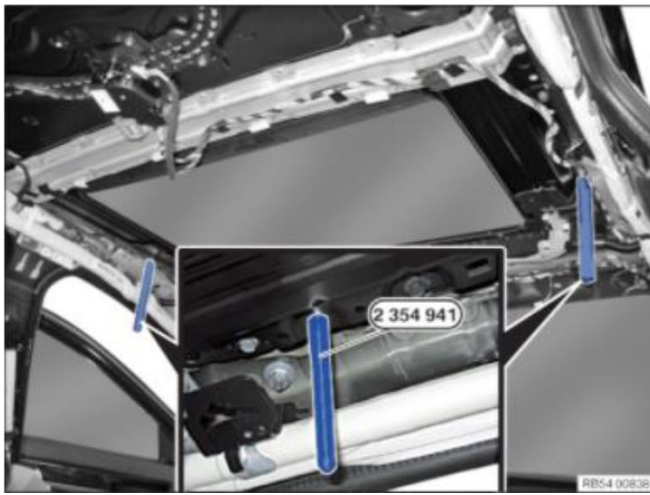
Note: The alignment tool will insert vertically, without tilting, if the sunroof frame is correctly aligned.

3. Lower the headliner to check the position of the sunroof frame using alignment tool 2 354 941 as shown.

Ensure the alignment tool fits easily and completely into the alignment bores. If the tool does not align correctly in the frame, loosen the frame bolts, adjust the frame as necessary, and torque the bolts to 9.5 Nm.

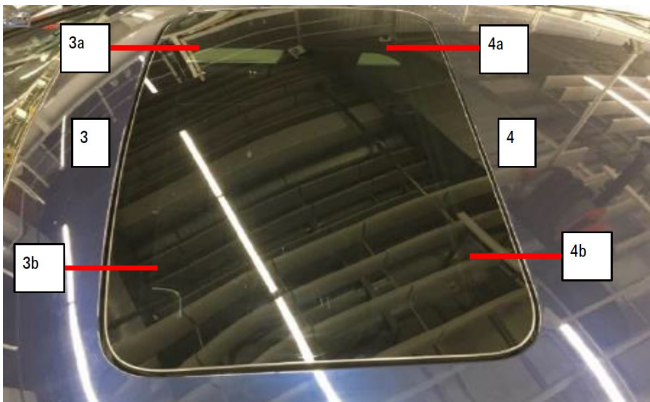
5. Similar to the measurements taken in step 2, compare the gap measurements at the front and rear of the glass.

Gap 3a should be 1 mm smaller than gap 4a.

Gap 3 should be 1 mm smaller than gap 4.

Gap 3b should be 1 mm smaller than gap 4b.

If the gaps are incorrect, adjust the sunroof glass panel following repair instructions **REP 54 12 003 "Adjusting glass slide/tilt sunroof panel"** and continue to step 6. If the gaps are correct, continue to step 6.
