SIB 61 06 15

## Washer Fluid Reservoir Rattles While Driving on Rough Roads

This Service Information Bulletin (Revision 3) replaces SI B61 06 15 **dated August 2017**.

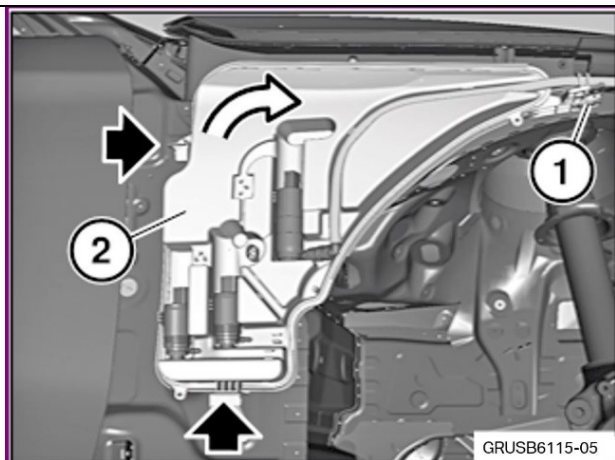
1. Remove the washer fluid reservoir as per Repair Instruction 61 71 061.  
Note: Accompanying picture shown is with the passenger side fender removed for purposes of clarity.
2. Remove the screw (1).  
Tightening torque = **8 Nm**.
3. Pull the washer fluid reservoir (2) out of the guides (arrow) in the direction of the arrow.
4. Unlock and disconnect all plug connections.
5. Unlock the filler hose and pull it off the fitting on the washer fluid reservoir.  
**Note: Capture any escaping washer fluid, if necessary.**

**Note: The close-up picture shows a gap (0.40 mm) that exists between the plastic reservoir guide and the metal securing bracket.**

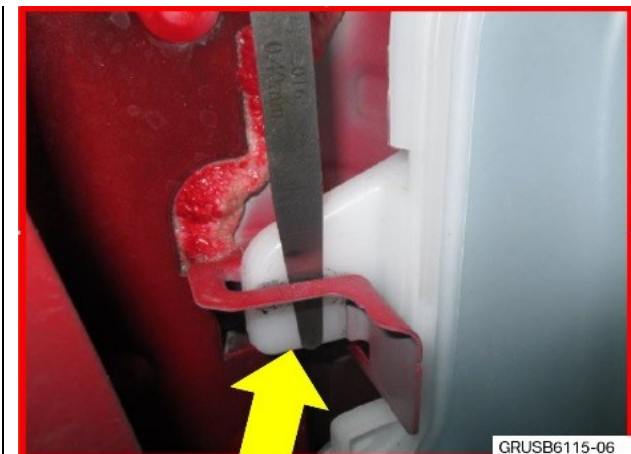
The windshield washer reservoir upper plastic locating guide tab has too much lateral play.

6. With the reservoir removed, clean the upper guide tab with a clean cloth.
7. Prepare a piece of felt tape (80 x 60 x 1 mm) and apply it to the guide tab in the area

shown.

8. The felt tape will eliminate the rattling noises coming from the metal bracket which can transmit into the glove compartment area. Reinstall the removed parts in the reverse order of their removal.
