SIB 63 05 21

2021-04-20

## AMBIENT LIGHT TUBE COLOR DIFFERENCES

E-Series	Model Description	Affected Option Code
G01	X3 Sports Activity Vehicle	4UR (Ambient Lighting)
G02	X4 Sports Activity Coupe	4UR (Ambient Lighting)

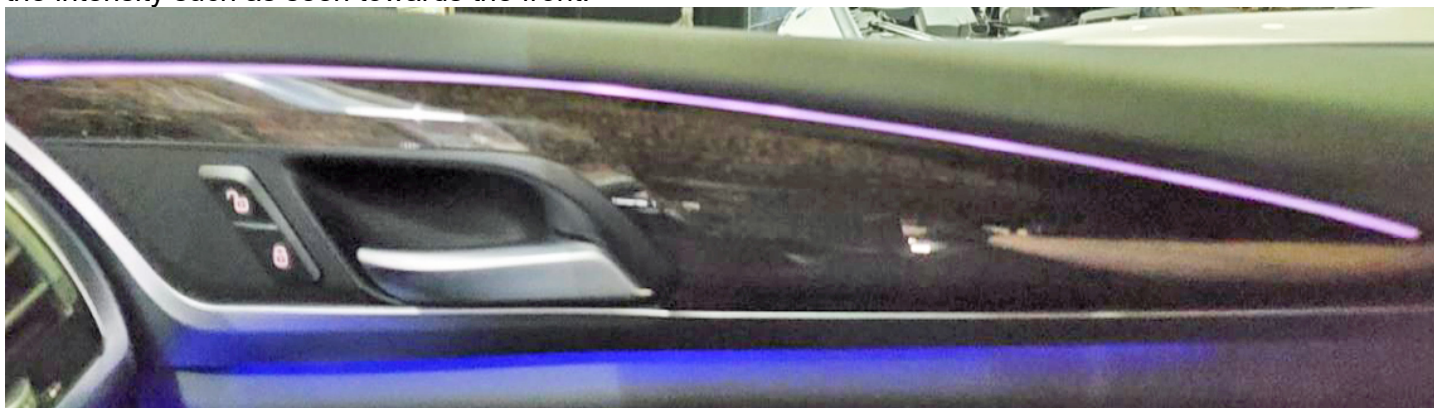
The intensity or light throughout the door panel lighting strips is not consistent. Some spots are brighter than others. This can happen on any of the 4 doors.

In the example shown below of the right front door, the light fades towards the rear instead of maintaining the intensity such as seen towards the front.

Unfavorable conditions of the ambient light tube.

Inspect the ambient light tube and light generator (LED) for moisture intrusion. Rework the ambient light tube if moisture is not found.
