SIB 64 01 21

WHISTLING NOISE COMING FROM FRESH AIR INLET (ENGINE COMPARTMENT)

E-Series	Model Description
F97	X3 M SAV
F98	X4 M SAC
G01	X3 Sports Activity Vehicle (SAV)
G02	X4 Sports Activity Coupe (SAC)

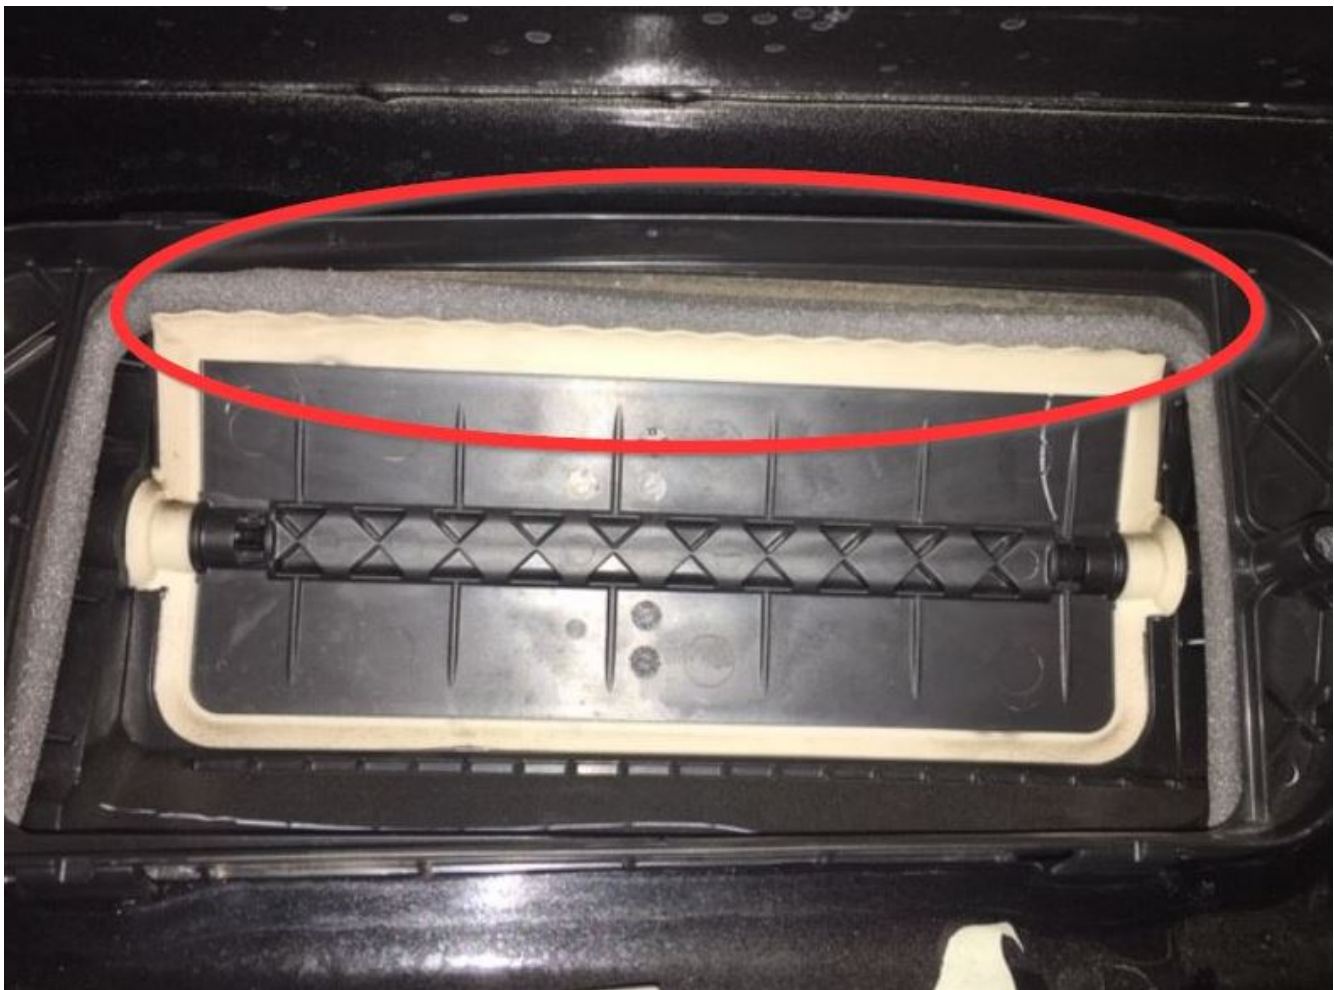
An unfavorably attached foam seal on the sealing frame of the fresh air inlet results in a gap between the foam and the sealing frame (circled). Unintentional air ingress can pass between the seal and the sealing frame.

Inspect the seal between the fresh air inlet and firewall for proper installation. If the seal is mispositioned, seal the gap with Butyl tape.

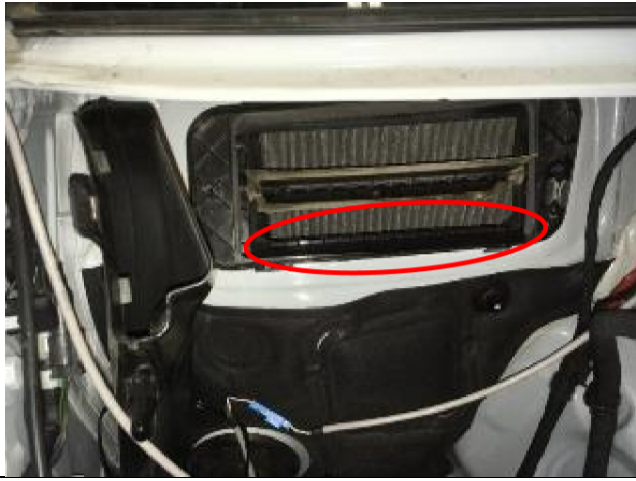
<p>2. Remove the diffuser of the fresh air intake. Once the inlet has been removed, check if the foam material is correctly installed.</p>
--	--

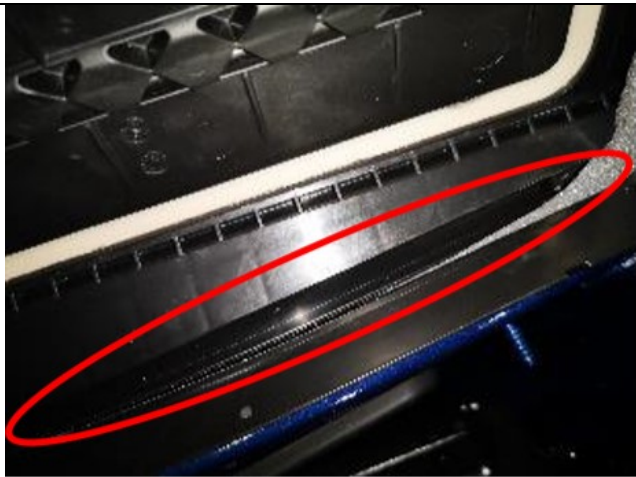
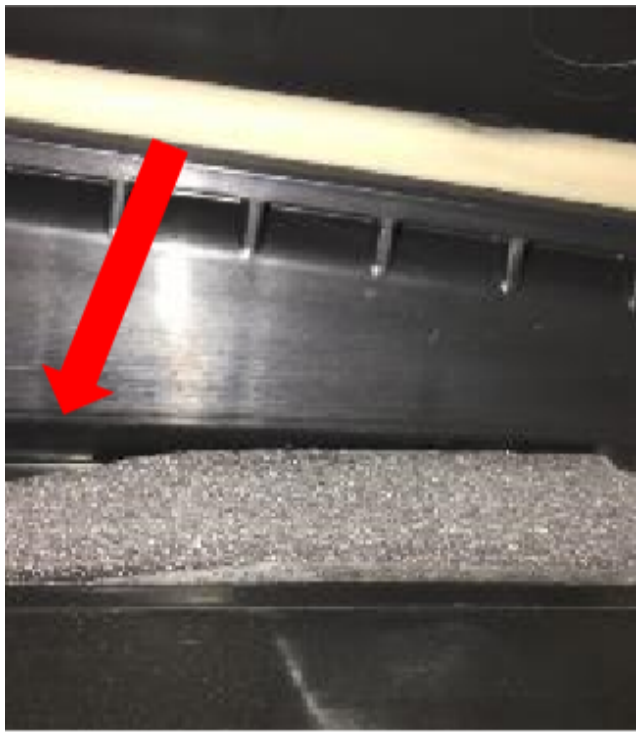
A mirror is helpful for checking the lower area of the sealing frame.

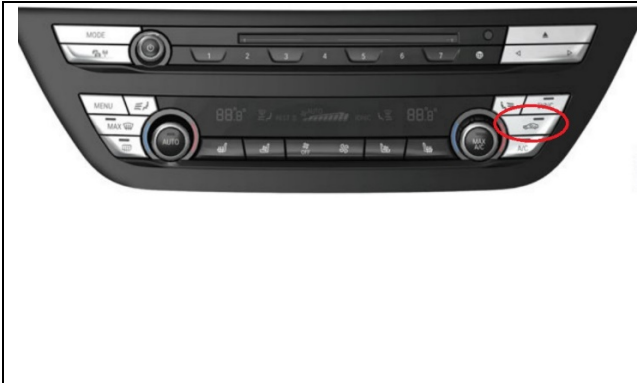
The flap position is always open when the vehicle is parked.
