SIB 11 06 21

ROCKER ARM REPLACEMENT GUIDELINES

Service Information Bulletin

Engine

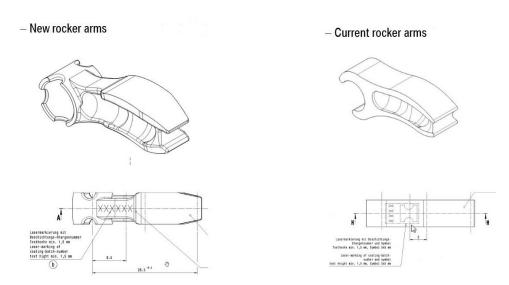
A redesigned rocker arm has replaced the older version in production motorcycles, as pictured below.

If ticking noises are caused by rocker arm wear, ALL rocker arms and damaged camshafts must be replaced, including in the opposite cylinder head on boxer engines. An oil change must also be completed after the repair.
