# Technical Service Bulletin

**97 Parking aid is not working, DTCs B10FA14, B10FA31, B10F804, B10F814, or B15EC14 are stored in the parking aid module**

97 21 80 2063269/1 May 17, 2021.

Model(s)	Year	VIN Range	Vehicle-Specific Equipment
Q3	2019 - 2020	All	Parking aid
Q3	2021	000001 - 084187	Parking aid

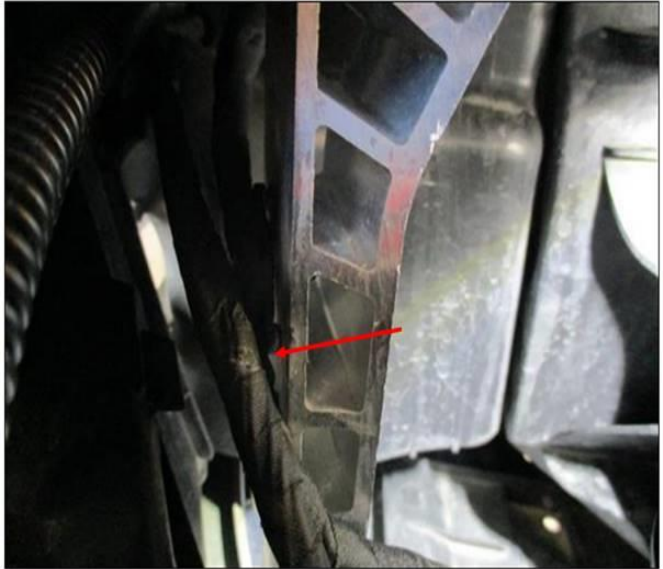
The wiring harness in the front bumper can rub against the bumper carrier causing it to chafe.

**Figure 1.** Example of parking aid harness that has chafing.

2. If damage is found on the wiring harness, replace the parking aid wiring harness.

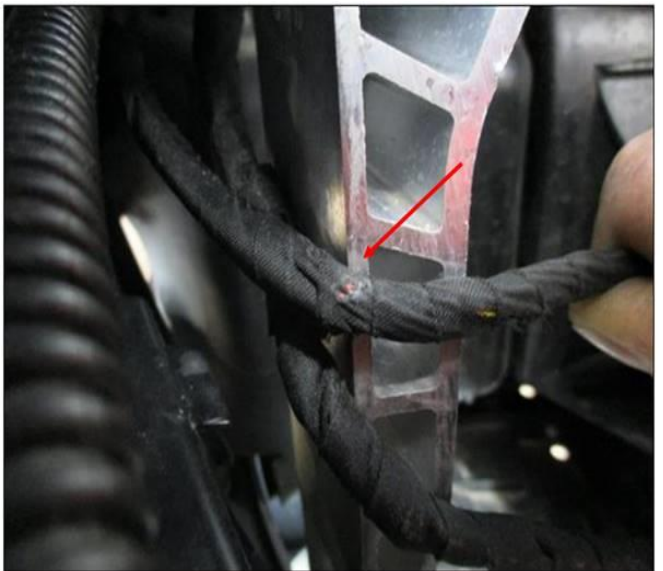
**Figure 2.** Example of parking aid harness that has chafing.
