MODEL
2021MY
Sportage (QL)

NUMBER
112

TECHNICAL SERVICE BULLETIN

SERVICE ACTION: REAR DIFFERENTIAL CARRIER OIL LEVEL CHECK/DIFFERENTIAL REPLACEMENT (SA480)

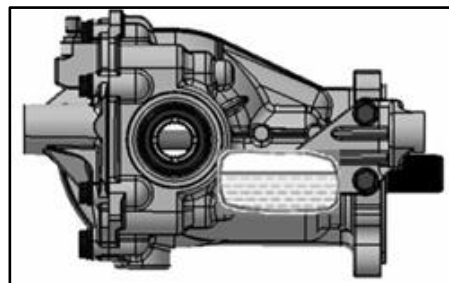
Rear Differential Carrier Assembly

This bulletin provides the procedure to check the rear differential carrier's oil level on the five (5) 2021MY Sportage (QL) vehicles listed below, produced from January 14, 2021 through February 2, 2021. These five (5) vehicles may have left the plant without any rear differential oil. If the rear differential carrier lacks oil, it will generate a grinding noise. Before conducting the procedure, verify that the vehicle is included in the five (5) affected VINs listed below.

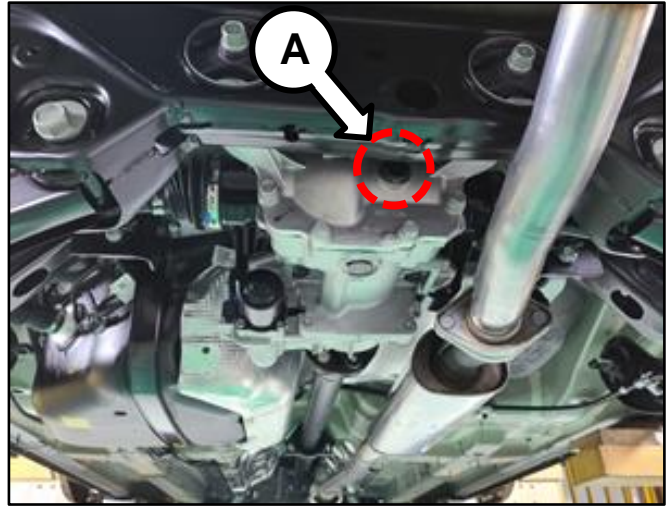
1. Raise vehicle on a lift.
2. Remove the differential oil filler plug (A).

Torque specification:

28.9 – 43.4 lb.ft (39.2 – 58.8 N.m)

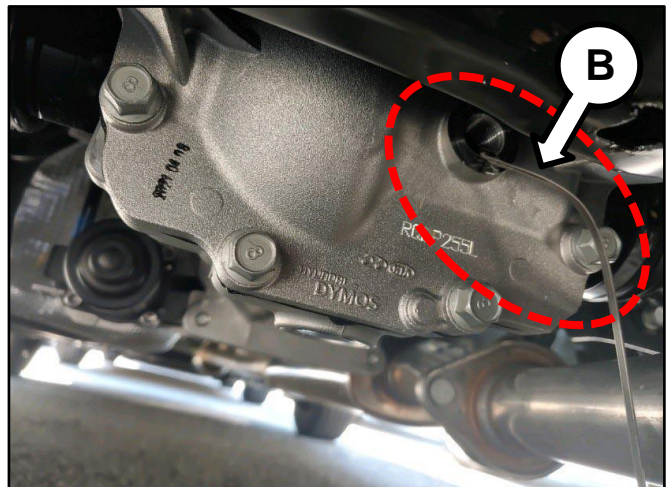
- 3a. Due to the subframe obstruction use a zip tie or similar object (B) to inspect the fluid level by inserting the tie as shown. Upon removal, fluid should be visible on the end of the tie.

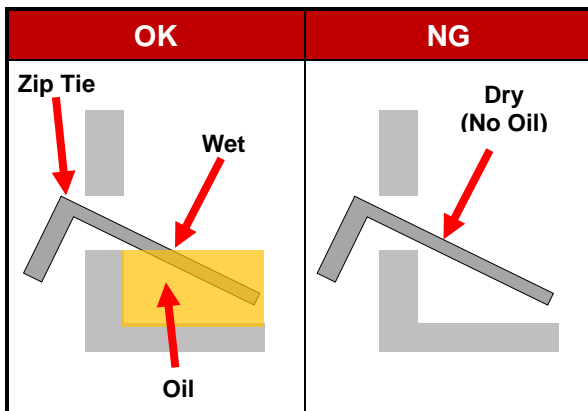
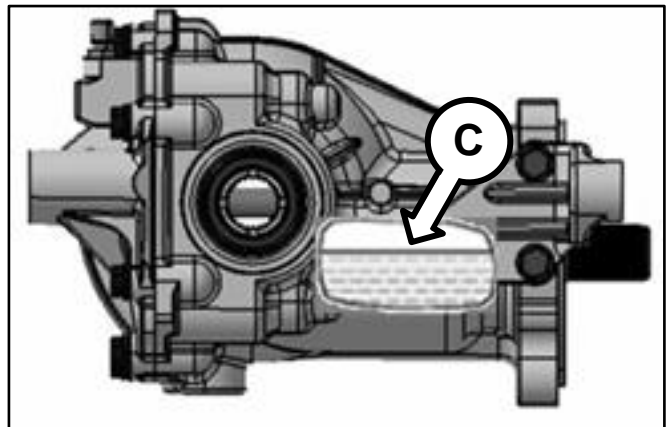
- 3b. Oil level (C) should be as shown ("OK") in the diagrams.

4. If no oil is detected, then replace the rear differential carrier by referring to the “Driveshaft and Axle → Differential Carrier Assembly → Rear Differential Carrier → Repair procedures” chapter in the applicable Shop Manual on KGIS.

Specified Lubricant:**Delo Syn-Gear Lube SAE 75W90****PN: UM015 CH079****Quantity: 0.61 ± 0.05 qt (0.58 ± 0.05L)**
