VOLUME 3	GROUP Body	MODEL 2009 Rio (4 door)
		NUMBER 042	DATE November 2008

TECHNICAL SERVICE BULLETIN

SUBJECT:
SERVICE ACTION: 2009 RIO FUEL DOOR ADJUSTMENT (SA004)

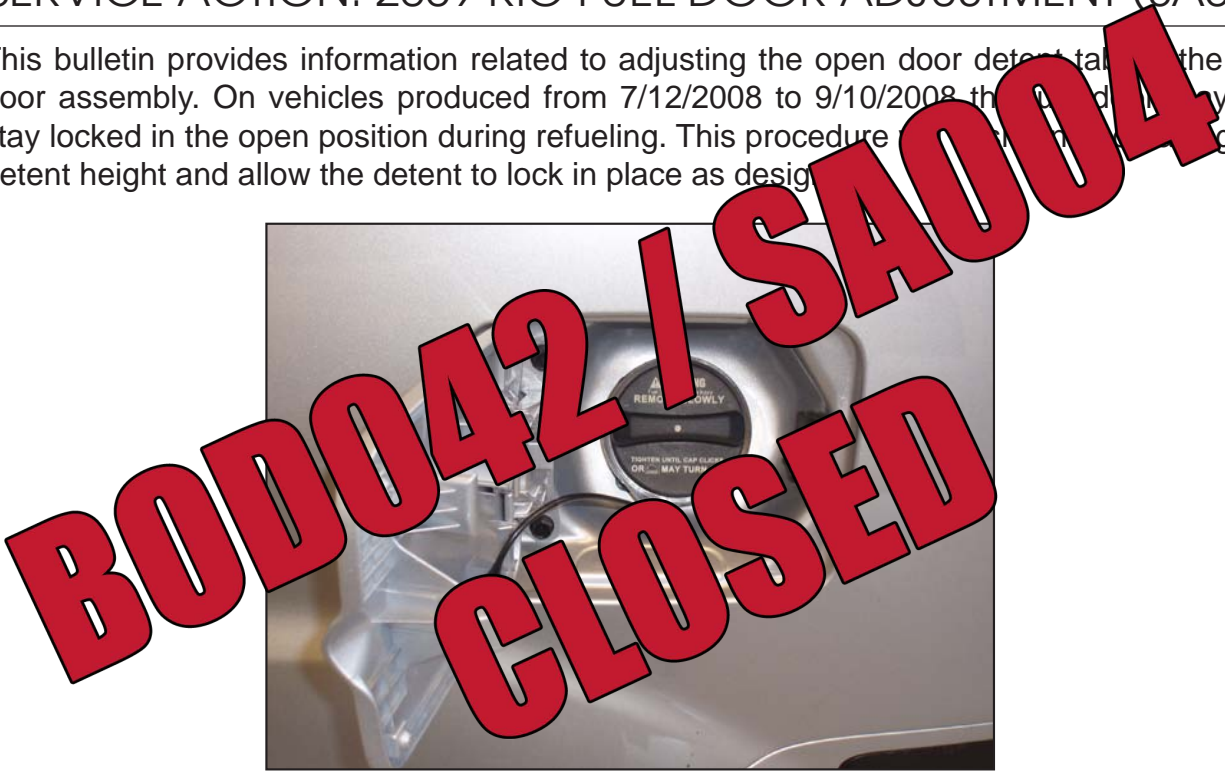
Fuel Filler Door Adjustment

This bulletin provides information related to adjusting the open door detent for the fuel door assembly. On vehicles produced from 7/12/2008 to 9/10/2008 the fuel door may not stay locked in the open position during refueling. This procedure involves adjusting the detent height and allow the detent to lock in place as designed.
