MODEL  
2009 Rio Sedan  
(4-Door)

NUMBER  
043

## TECHNICAL SERVICE BULLETIN

SERVICE ACTION: 2009 RIO REAR LEFT DOOR  
QUARTER GLASS ADJUSTMENT (SA005)

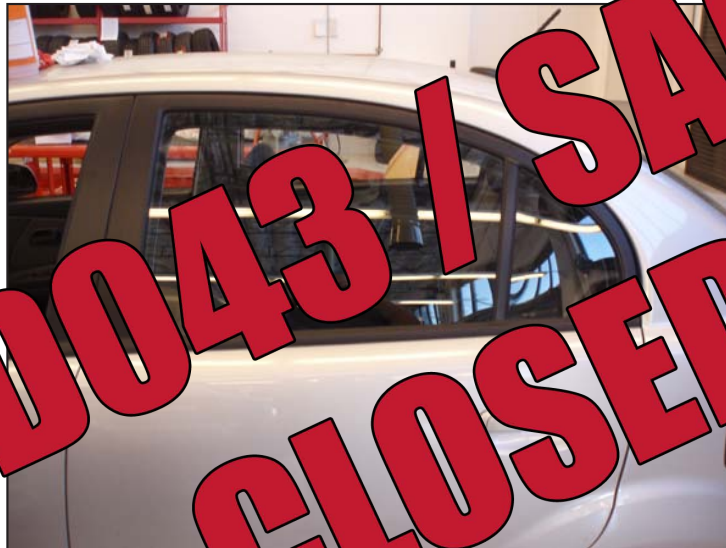
This bulletin provides information related to adjusting the rear door quarter glass to decrease a concern with wind noise. On some vehicles produced from 7/12/2008 to 9/10/2008, a gap may exist between the door frame and glass run causing wind noise at freeway speeds. This procedure will set the left rear quarter glass and weather-strip in the proper position to decrease excessive turbulent wind noise.

Rear Door Quarter Glass Adjustment - L/R Door Only
