**KIA MOTORS**

MODEL  
2010MY Soul (AM)

NUMBER  
045

**SERVICE ACTION: SOUL (AM) A/C IDLER PULLEY NUT TORQUE (SA007)**

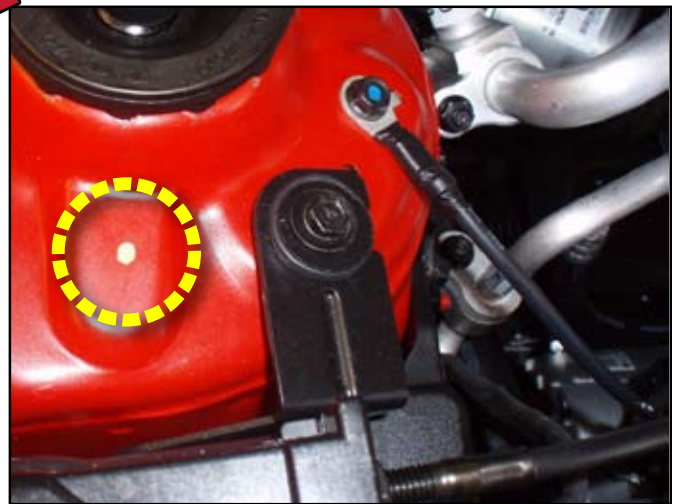
1. Open hood and check for yellow or orange paint dot on the right front strut tower as shown. **If the yellow or orange dot is present no further action is required.**

If the paint dot is not present proceed to the repair instructions below.
