MODEL  
2010 Forte (TD)  
w/6-speed M/T

NUMBER  
026

DATE  
October 2009

**SUBJECT:** SERVICE ACTION: DRIVESHAFT HOUSING AND TRANSAXLE OIL SEAL INSPECTION AND REPLACEMENT (SA011)

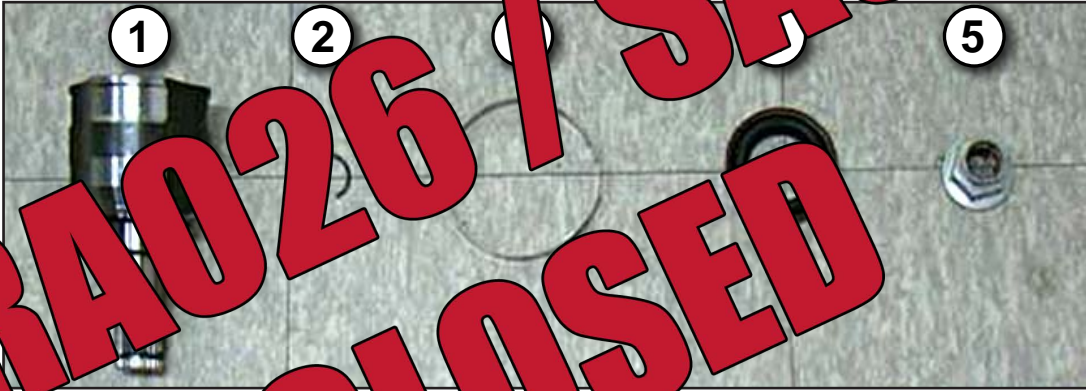
<b>Part Name</b>	Drive Shaft Housing & Oil Seal Kit
<b>Part No.</b>	49592 1M24MQQK
<b>Components</b>

This Service Action provides information related to 2010 Forte (TD) produced from 2/23/2009 ~ 8/12/2009 equipped with 6-speed manual transaxles. Some 2010 Forte vehicles may have interference with the inner tri-pod housing contacting with the axle seal cage. This bulletin describes the procedure for replacing the inner tri-pod housing on both left and right side axle shafts. Follow these instructions as some left and right hand replacement components are different and angles

<ol style="list-style-type: none"> <li>1. Inner Tri-pod Housing (Left side - Larger radius, Right - smaller radius)</li> <li>2. Spring Clips: (2)</li> <li>3. Band Clamps: (2) (Left side - Larger radius, Right - smaller radius)</li> <li>4. Oil seal: 2 (Left side - Black, Right side - Black)</li> <li>5. Axle Nuts: 2</li> <li>6. Grease 50g: 25g per side (Not shown)</li> </ol>
<b>Remark</b>	<ul style="list-style-type: none"> <li>• Radius of left side drive shaft housing and band clamp is larger than the Right side.</li> <li>• LH and RH oil seals differ. They are identified by marks on them and by color.</li> </ul>
