KIA MOTORS

MODEL
2010MY Rio [JB]

TECHNICAL SERVICE BULLETIN

SUBJECT: SERVICE ACTION: STABILIZER BAR LINK UPPER MOUNTING NUT RETORQUEING (SA034)

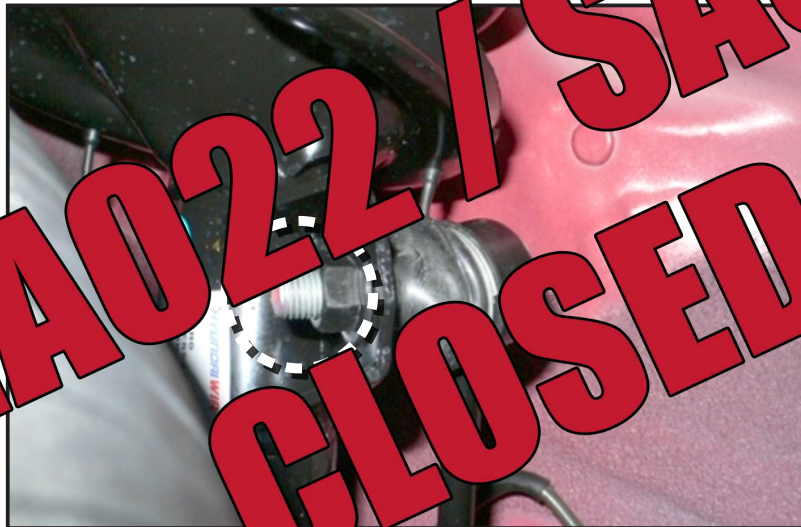
Stabilizer Bar Link Upper Mounting Nut

This bulletin provides information relating to some Rio (JB) vehicles built from Nov. 6, 2009 to Nov. 20, 2009. On some affected vehicles the right and left stabilizer bar link upper mounting nut(s) may have been insufficiently torqued, permitting some metal-to-metal contact that may result in squeaking noise.
