GROUP Engine	MODEL 2.4L Forte/Koup A/T
NUMBER <b>058</b>	DATE October 2009

### TECHNICAL SERVICE BULLETIN

SERVICE ACTION: PCM UPGRADE "REVERSE" POSITION

RPM IMPROVEMENT (SA018)

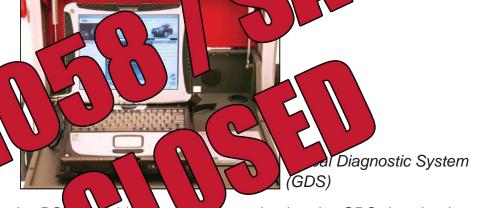
KMA is conducting a Service Action in relation to some 2010 MY Forte Sed Koup with 2.4L engines. Some vehicles may experience a noise/droan from the compartment after shifting to reverse gear. Since the idle is slightly high starts, the higher idle RPM create a noise (from the rear roll-stop due to cell et at mount area). This PCM upgrade will lower the RPM range which is produced prior to October 17, 2009.

To condition, the PCI could be ammed using the GDS download as described in this bulletin.
