Technical Service Bulletin

19 Coolant leak in area of coolant thermostat housing/coolant pump - 2.0TFSI

19 21 18 2061604/4 May 28, 2021. Supersedes Technical Service Bulletin Group 19 number 21-15 dated April 1, 2021 for reasons listed below.

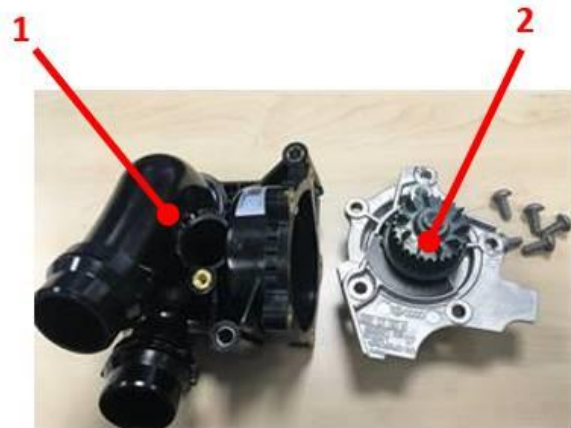
Coolant loss from the coolant thermostat housing (Figure 1, position 1) or the coolant pump (Figure 1, position 2).

Figure 1. Coolant thermostat/coolant pump. Parts are available separately, see parts table below.

Only replace the leaking component (coolant pump or coolant thermostat housing).

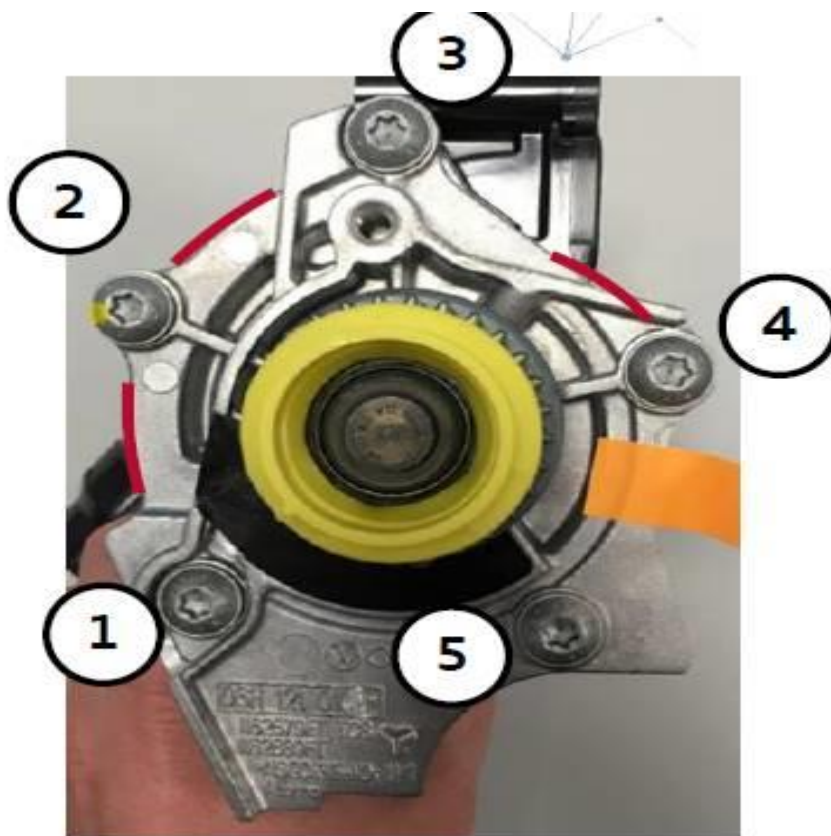
Figure 2. Securing bolts of the coolant pump (1 to 5).

- Assemble the coolant thermostat housing and the coolant pump and attach the five connecting bolts.
- Align the two components against one another in such a way that both components are flush to one another in the areas marked in red (Figure 2). The thermostat housing must not be higher/lower than the coolant pump (run your finger over the three areas to check).
- Torque the connecting bolts of the two components to 10 Nm.

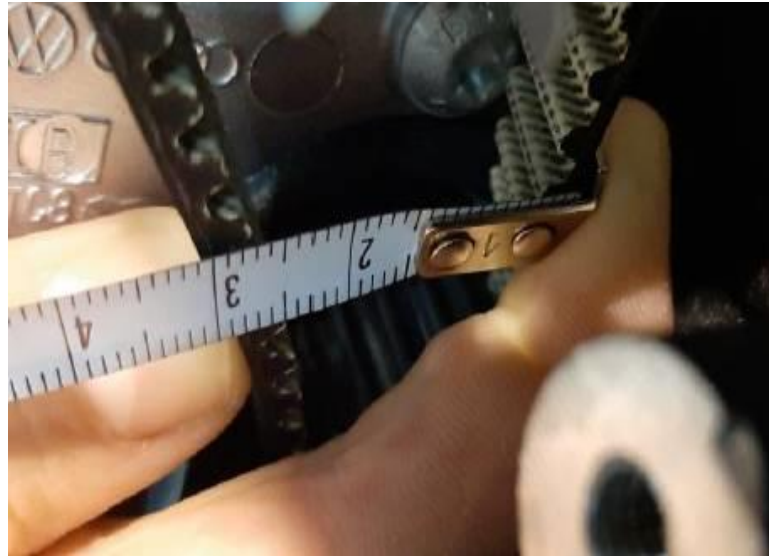
Figure 3. Checking the toothed belt tension.

- 5) Check the toothed belt tension (Figure 3) by pressing the toothed belt together centrally between the two toothed belt sprockets. The measured distance of the backs of the toothed belt should be between 28mm and 30mm. A measuring caliper can also be used for toothed belt compression and measurement.

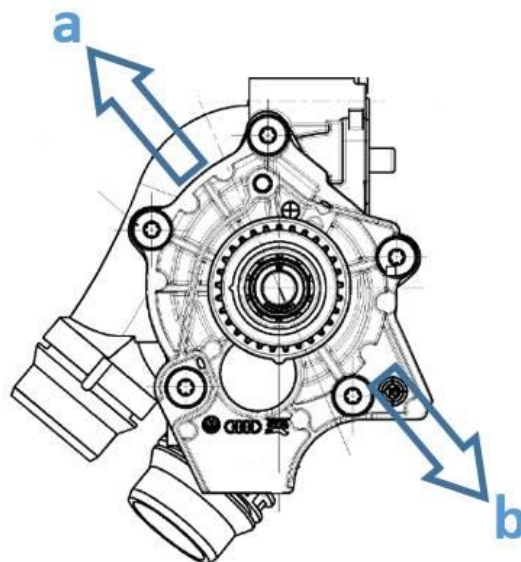
Figure 4. Adjusting the toothed belt tension.

- Note down the measured value (e.g. 26mm) from step 5).
- Remove the cooling module from the engine again, loosen the coolant pump bolts (Figure 2) and make adjustments as outlined below.
- If the measured distance of the backs of the toothed belt (pressed together) is less than 28mm (e.g. 25mm), then the belt tension is too low. A slight adjustment away from the balance shaft is necessary (**direction "a"**).
- If the distance of the backs of the toothed belt (pressed together) is greater than

28mm (e.g. 32 mm), then the belt tension is too great. A slight adjustment towards the balance shaft is necessary (**direction "b"**).
