Technical Service Bulletin

87 Noise from the air conditioning compressor when the AC is active

87 21 14 2063467/1 May 28, 2021.

| Model(s) | Year | VIN Range | Vehicle-Specific Equipment |
|---|---|---|---|
| Audi e-tron quattro | 2019 - 2021 | All | Not Applicable |

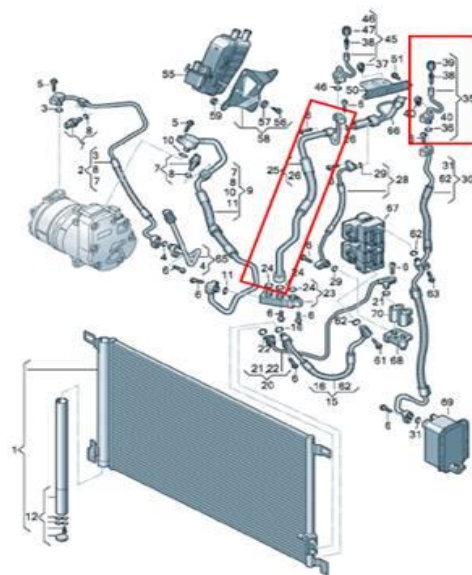
The source of this noise may be due to direct contact between the two refrigerant lines (Figure 1). When the air conditioning compressor is operating the noise created by the vibration is transferred from this point of contact and into the cabin.

Figure 1. The refrigerant lines are making contact.

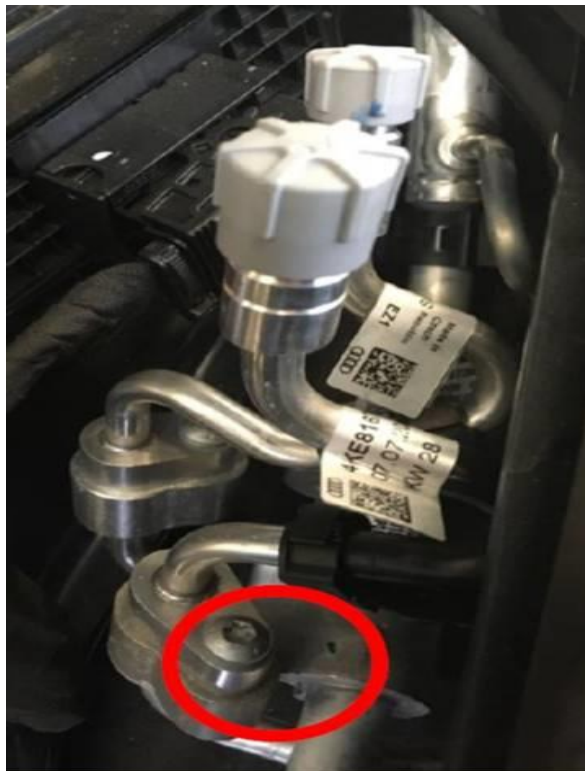
1. Figure 2 shows the refrigerant lines are close enough to make contact to elicit the noise.

Figure 2. The refrigerant lines are making contact.

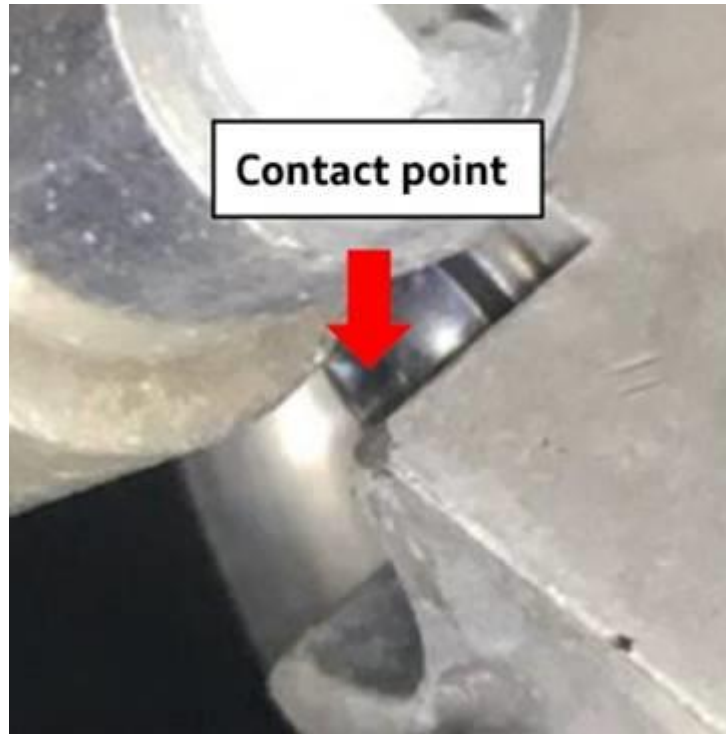
2. Figure 3 shows a close-up view of the point of contact.

Figure 3. Point of contact.

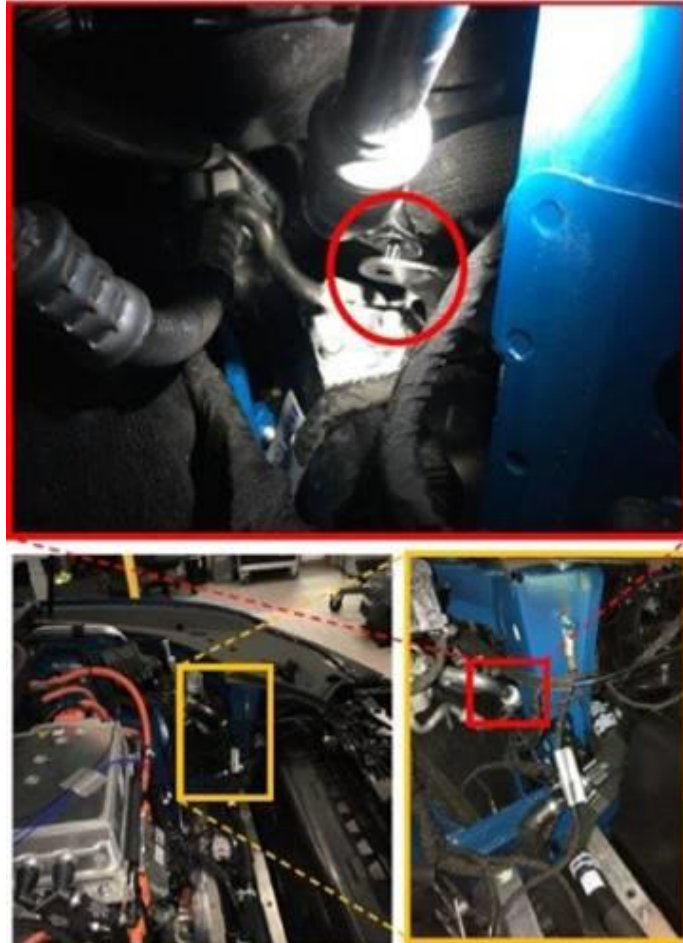
Figure 4. The area in the motor bay where contacting lines are located.

3. These refrigerant lines must be separated and, if necessary, retained in a separated state using a hose holder, clip, or tie-wrap (Figure 4).

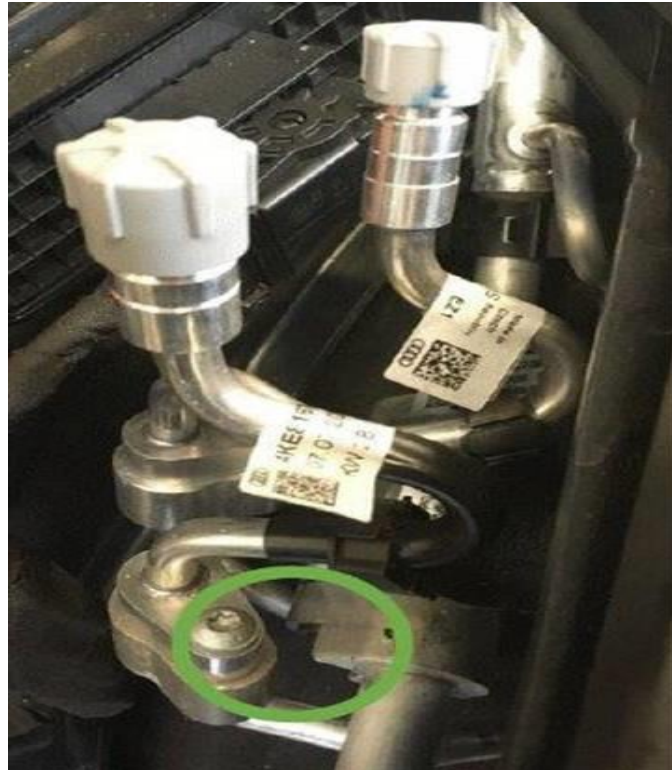
4. Figure 5 shows properly separated refrigerant lines.

Figure 5. The refrigerant lines have been separated.
