# Technical Service Bulletin

<b>Subject:</b>  LIFTGATE SWITCH DOES NOT WORK	<b>Bulletin No.:</b> 09-015/21
	<b>Last Issued :</b> 05/25/2021

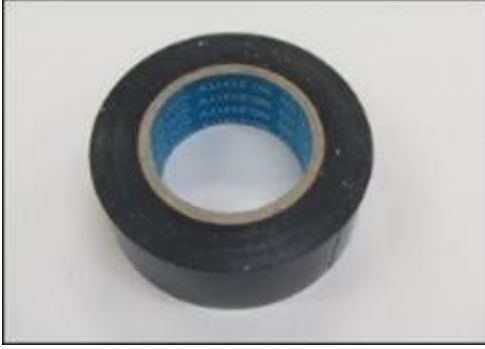
2. Inspect the connector for traces of water or moisture.

- If water or moisture is visible, but the parts are not rusted, wrap the connector with PVC tape to make it waterproof according to "INSTRUCTIONS FOR WRAPPING THE CONNECTOR".

- If some rust is visible, replace the rusted parts with new ones following steps a) and b) below.
