Technical Service Bulletin

RUST OR PAINT PEELING AT INSIDE EDGE OF FRONT DOOR(S)

Bulletin No.: 09-016/21

2017-2020 CX-5 vehicles with VINs lower than JM3KF*****869654 (produced before Aug. 24, 2020) 2021 CX-5

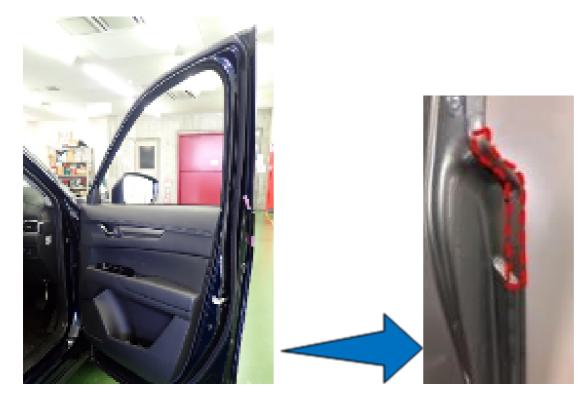
Some vehicles may exhibit rust or paint peeling at the inside edge of the front door(s). This may be caused by dust adhering between the front door edge and the rear door weatherstrip, which rubs/damages the paint during vehicle operation (door opening/closing and vibration while driving).

Customers having this concern should have their vehicle repaired using the following repair procedure.
