Subject: VEHICLE KEY OR REMOTE START WILL NOT PROGRAM	M-Tips No.: MT-002/21
	Last Issued : 05/07/2021

APPLICABLE MODEL(S)/VINS

2010-2021 Mazda3	2009-2021 Mazda6	2020-2021 CX-30	2016-2021 MX-5
2013-2021 CX-5	2016-2021 CX-3	2007-2021 CX-9

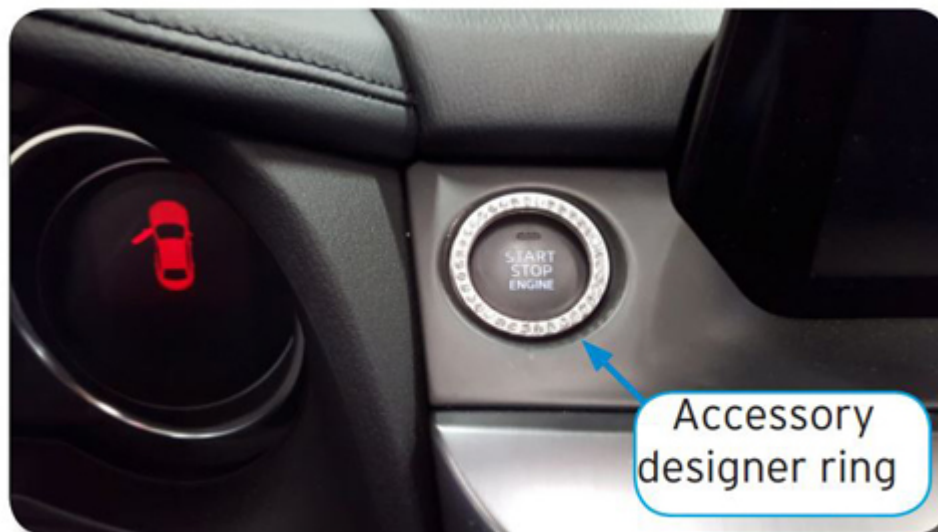
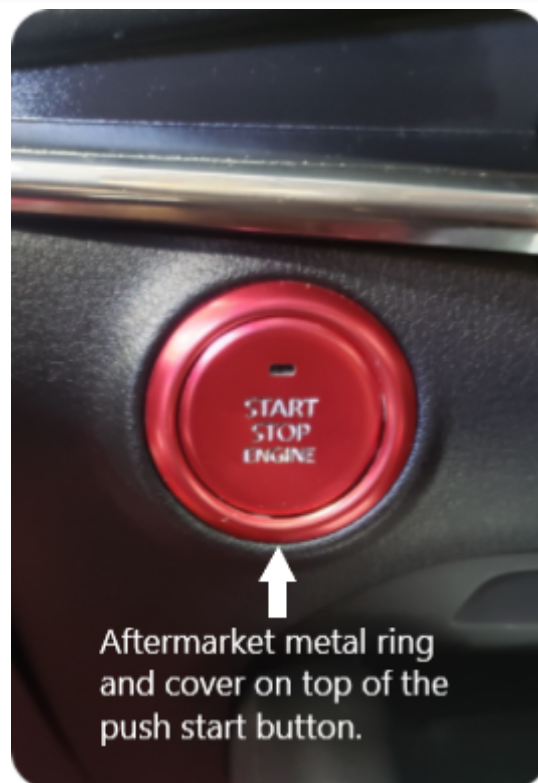
When programming a key or installing a Genuine Mazda Accessory Remote Engine Start system, you may encounter programming difficulty. This may be caused by a customer installed aftermarket decorative trim and/or cover on the START/STOP ENGINE button.

The aftermarket accessory may create electrical interference, which may interfere with programming.
